# Ground Up Home Inspections

Inspected By: Manny Theocharidis. Lic # 16000098512

## Residential Inspection Report

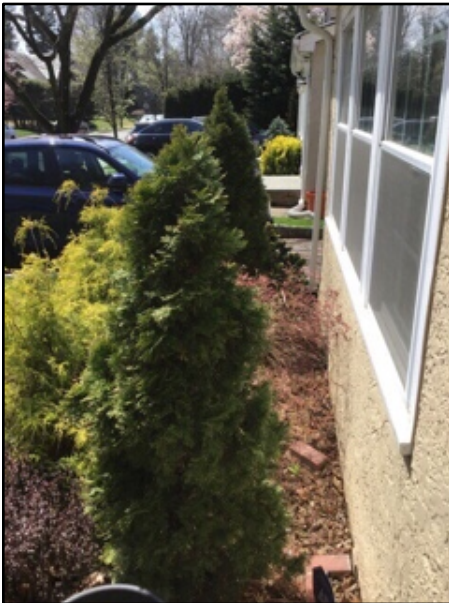
Figure 1-1

Shrub and tree growth are far enough away from the siding and/or roof of the house. Regular maintenance and pruning should be done on an ongoing basis to prevent contact in the future which could lead to wood rot and unwanted moisture contacting the siding of the house.

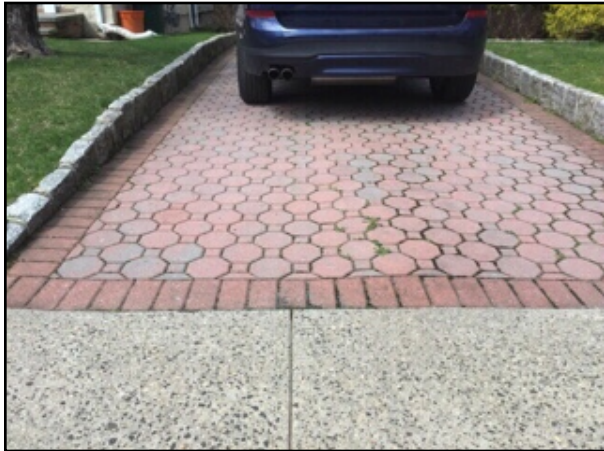
Figure 2-1

The property appears to not be graded properly to allow rain water and melting snow to divert away from the structure when there is a normal amount of precipitation. Recommend monitoring areas around the foundation within 6' for ruts and depressions where areas of water can collect and pool.

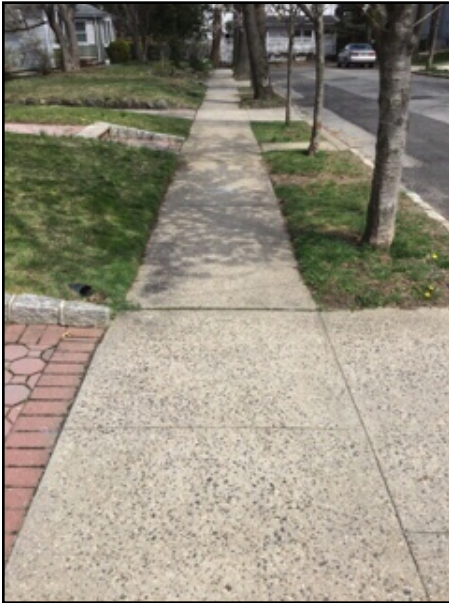
Figure 3-1

The front walkway is in marginal condition with defects noted. Salt and snow melting products are the biggest contributors to surface deterioration. Regular maintenance is required to keep the walkway from deteriorating and cracking.

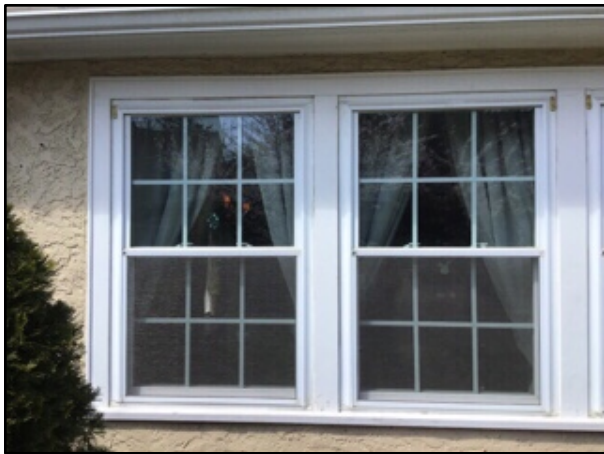
Figure 5-1

The majority of the exterior wood trim of the windows is in poor condition with peeling paint and areas that have started to rot. Recommend hiring a qualified contractor to assess and repair or replace as necessary.

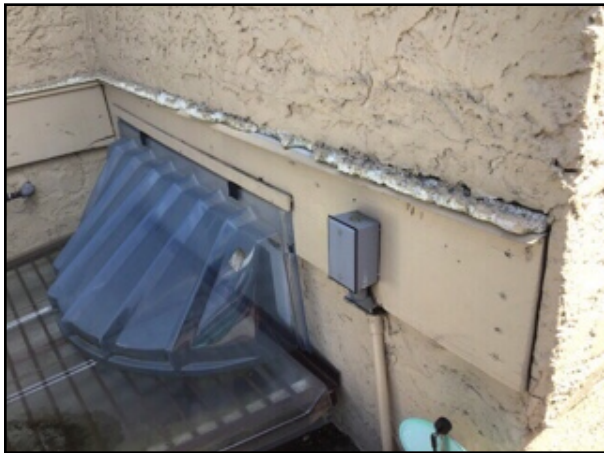
Figure 10-1

The exterior stucco has damage. Unable to inspect behind EIF'S (exterior insulation and finish system) to see if there is any water penetration. Have a licensed EIF'S specialist review for possible repair. If water damage is found have reviewed and repaired by a licensed mold contractor.

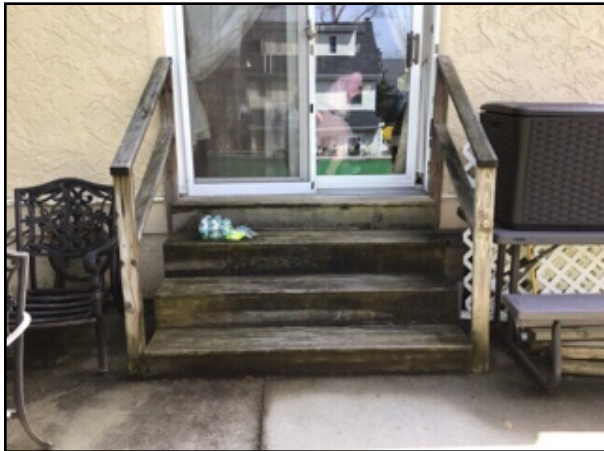
Figure 11-1

The rear steps are in an unsafe condition as they are loose and deteriorating. Recommend hiring a qualified contractor to assess and repair as necessary.

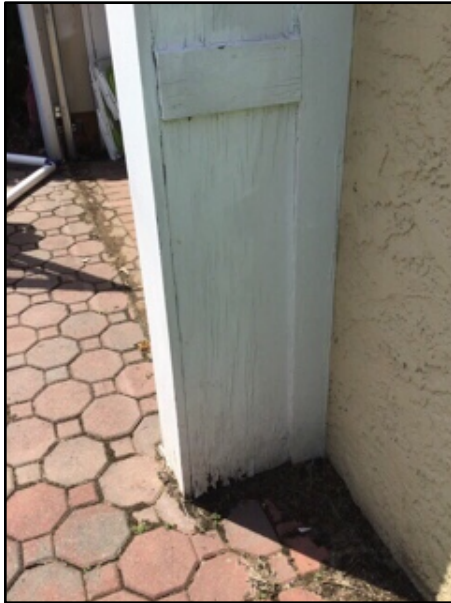
Figure 12-1

The garage door shows deterioration on bottom of side jambs.

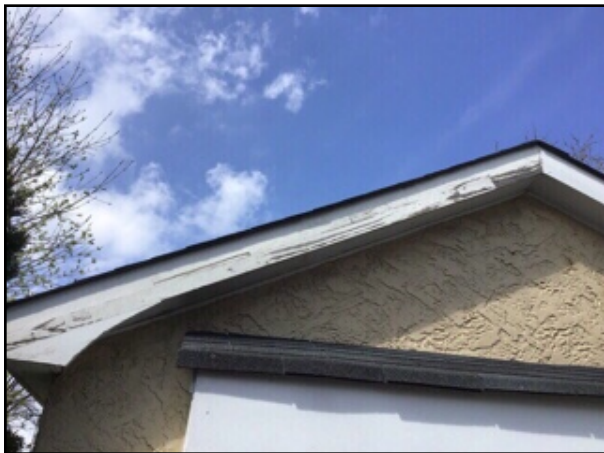
Figure 15-1

The fascias and soffits of the garage are wood and in poor condition with defects noted.

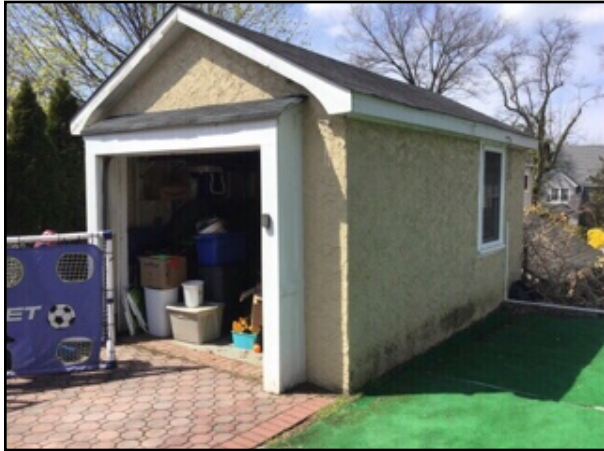
Figure 17-1

The 1 car attached garage is in marginal condition with defects noted. The garage door opener closed and reversed properly when the photo eye was engaged.

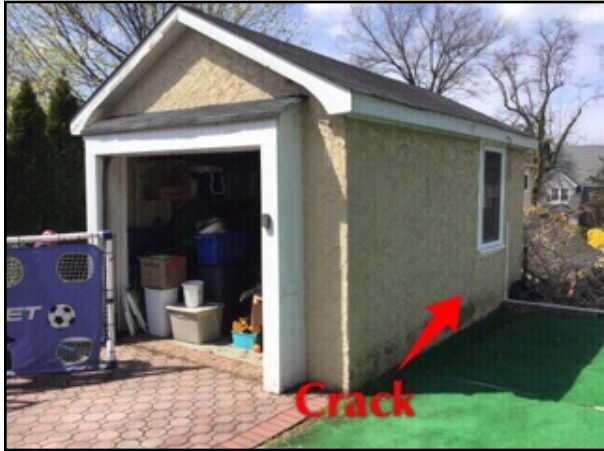
Figure 19-1

The side exterior wall was in poor condition with visible crack. Recommend hiring a qualified mason to assess and repair as necessary.

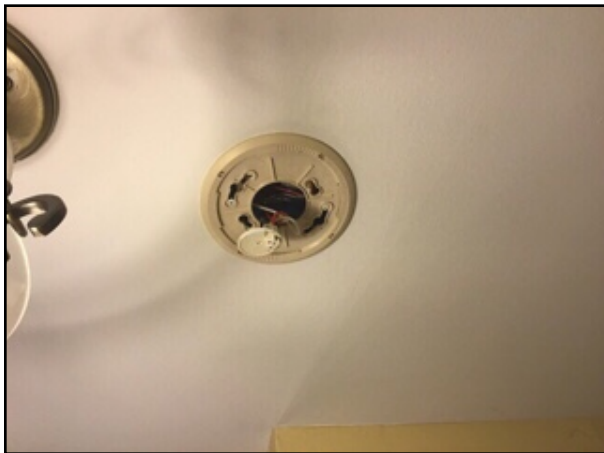
Figure 27-1

Smoke and carbon monoxide detectors are important safety devices designed to save lives. It is always recommended to install new detectors when moving into a home if they are 9 volt battery operated. Noticed on day of inspection some smoke detectors are hard wired and missing. Recommend hiring a licensed electrical contractor to evaluate.

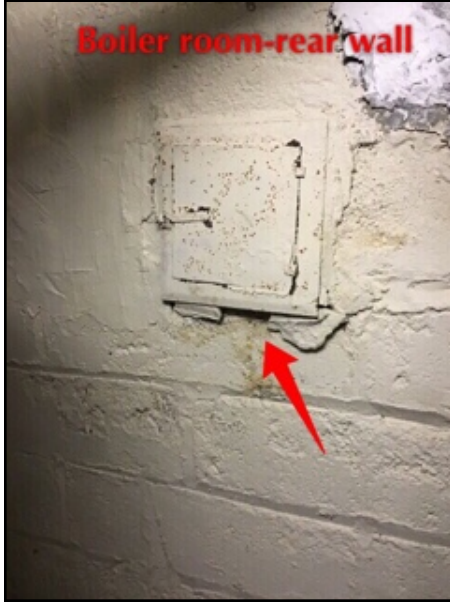
Figure 31-1

Clean out in boiler room needs to be properly sealed. Recommend hiring a licensed mason to repair.

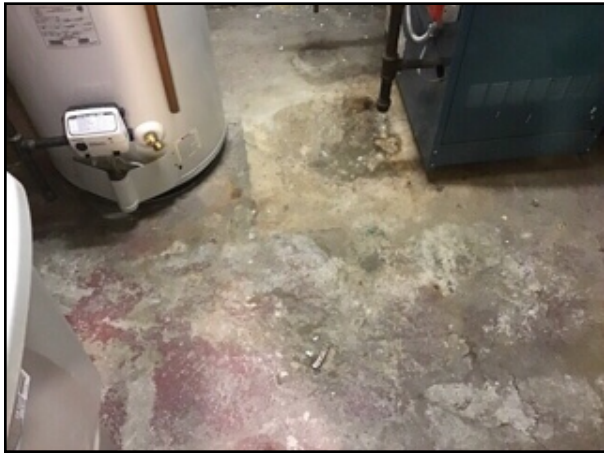
Figure 37-1

**Comment 37:**  
The boiler was located in the basement, there was no sign of a floor drain.  
Recommend hiring a licensed plumber to further evaluate.

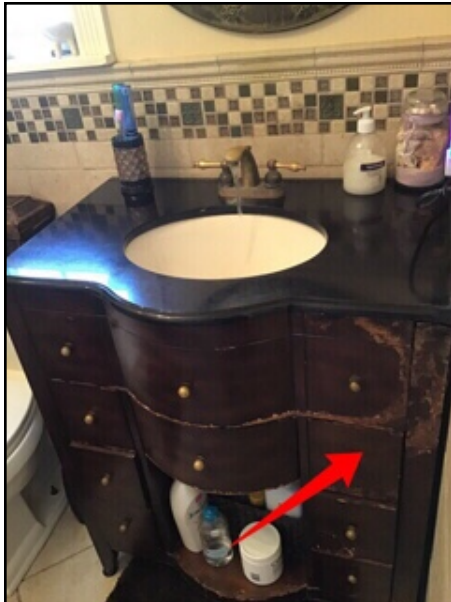
Figure 40-1

Comment 40:  
2nd floor main bathroom, vanity shows sign of wear.

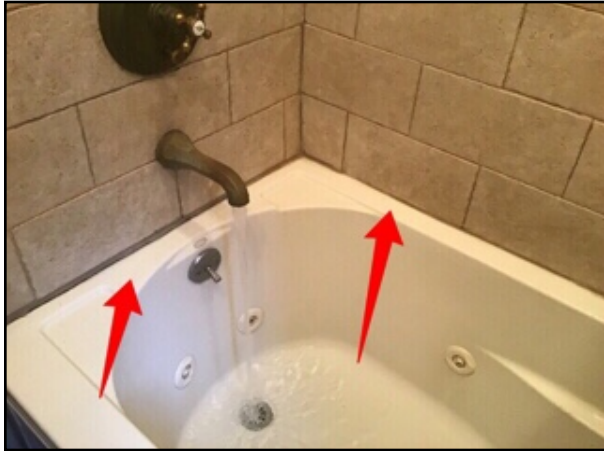
Figure 41-1

Bathroom on the second floor needs recaulking in tub area. Recommend hiring a licensed contractor to further evaluate.

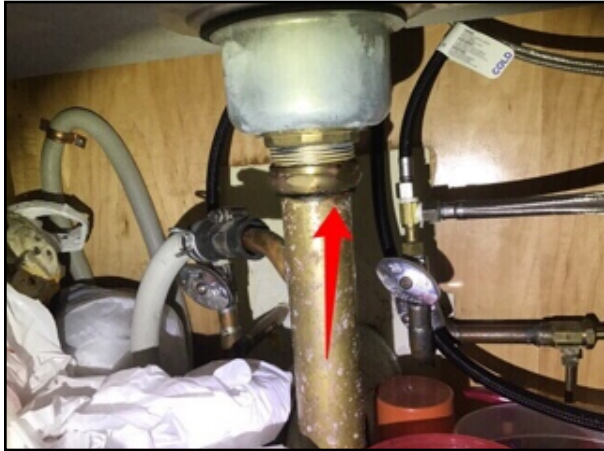
Figure 43-1

The waste pipe under the sink shows signs of corrosion. Recommend hiring a licensed plumber to further evaluate.

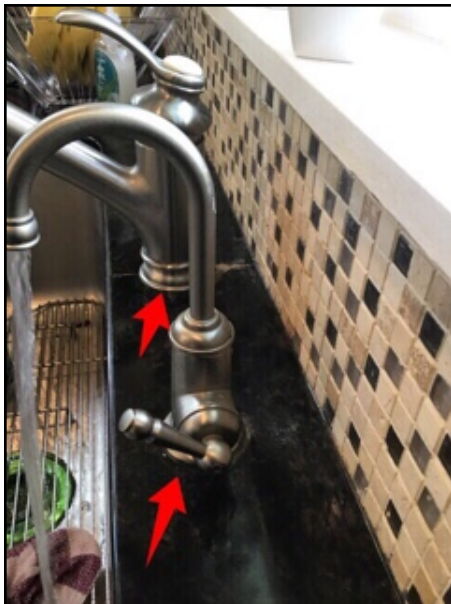
Figure 44-1

The kitchen faucet leaks around mount. Recommend hiring licensed plumber to further evaluate.

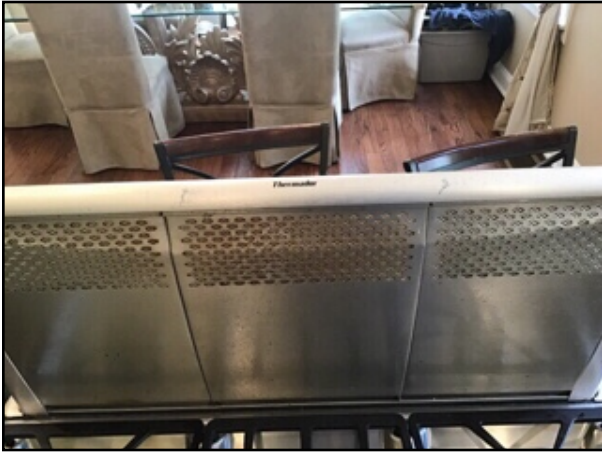
Figure 46-1

On day of inspection, retractable stove top exhaust was not working properly. Recommend hiring a appliance repair company for further inspection.

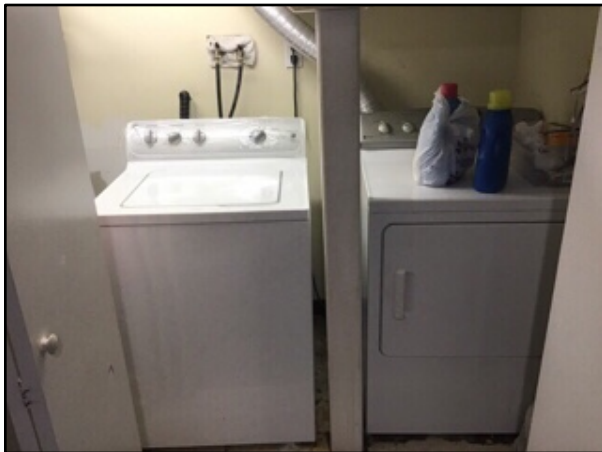
Figure 47-1

The laundry area was in marginal condition with defects noted. There were no leaks at the washing machine connections .

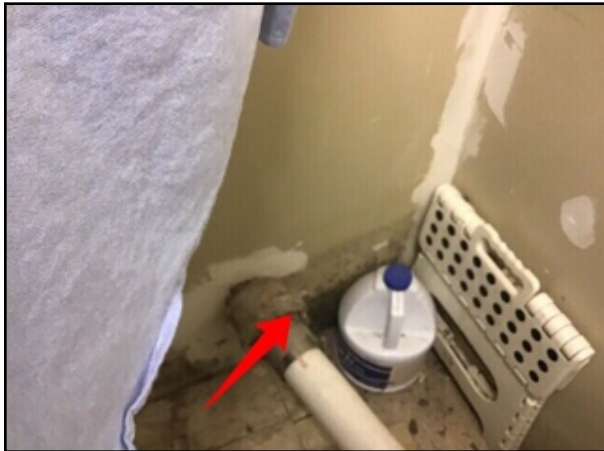
Figure 49-1

**Comment 49:**  
Possible signs of mold in laundry room . Recommend hiring a licensed mold inspector to further evaluate.

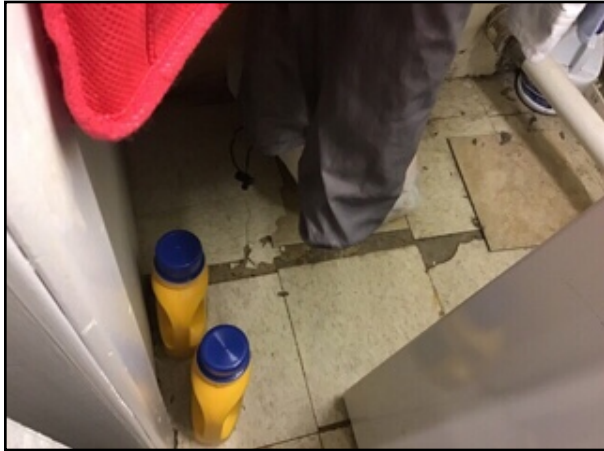
Figure 50-1

Laundry room has loose floor tiles. Recommend hiring a licensed contractor to repair.

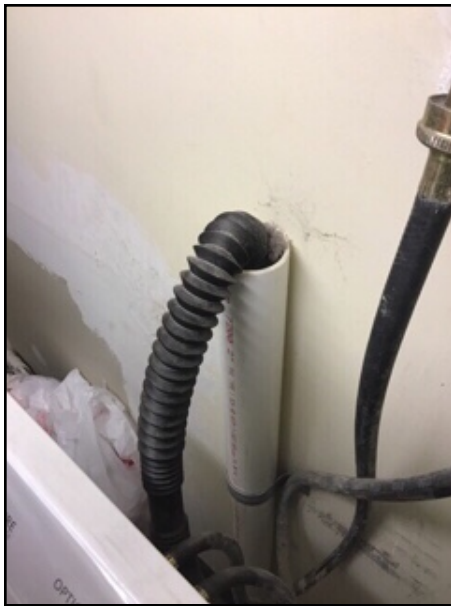
Figure 51-1

The washing machine drain line is not properly secure. Signs of possible leak. Recommend hiring a licensed plumber for further evaluation.

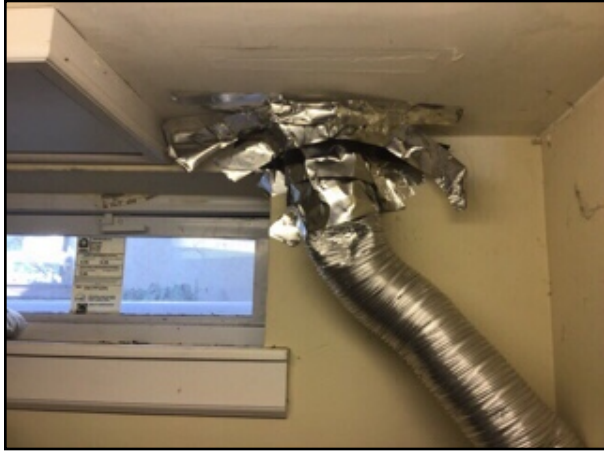
Figure 52-1

The dryer exhaust vent is not installed properly and not properly vented out to the exterior. This needs immediate attention. Do not recommend operating dryer until a licensed contractor further evaluates.

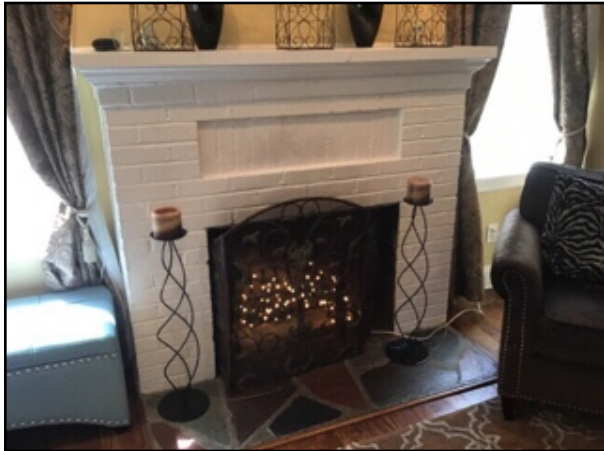
Figure 54-1

The fireplace is in marginal condition . It is ALWAYS recommended to have the flue inspected and cleaned prior to use. Recommend hiring a qualified chimney company to assess and repair as necessary. Damper was not tested on day of inspection.

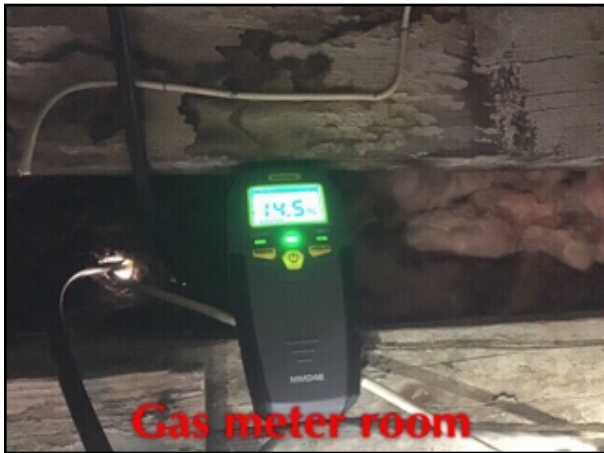
Figure 55-1

The basement has signs of moderate moisture and dampness. Structure and framing appear to be proper and to the building methods of the time it was built. Recommend hiring a qualified basement waterproofing contractor to assess and recommend a proper drainage system or repair as necessary.

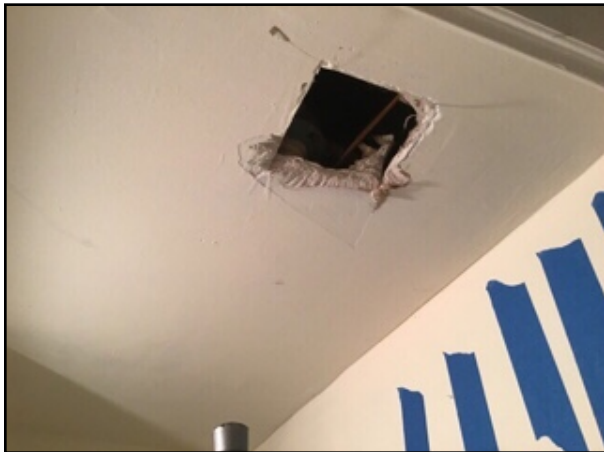
Figure 56-1

The ceiling in the storage closet in the basement needs repair. Recommend hiring a licensed contractor to repair.

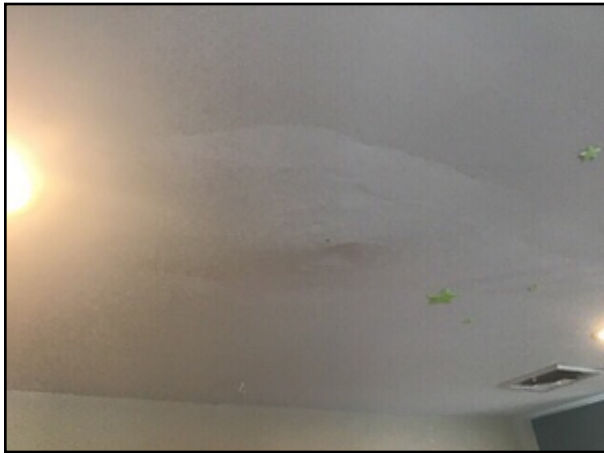
Figure 57-1

The ceiling is peeling as a result from water leak above. Recommend hiring a licensed contractor for further evaluation.

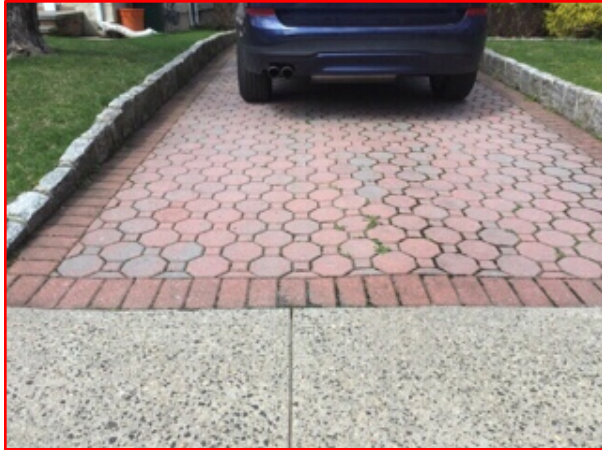
Figure 2-1

1) The property appears to not be graded properly to allow rain water and melting snow to divert away from the structure when there is a normal amount of precipitation. Recommend monitoring areas around the foundation within 6' for ruts and depressions where areas of water can collect and pool.

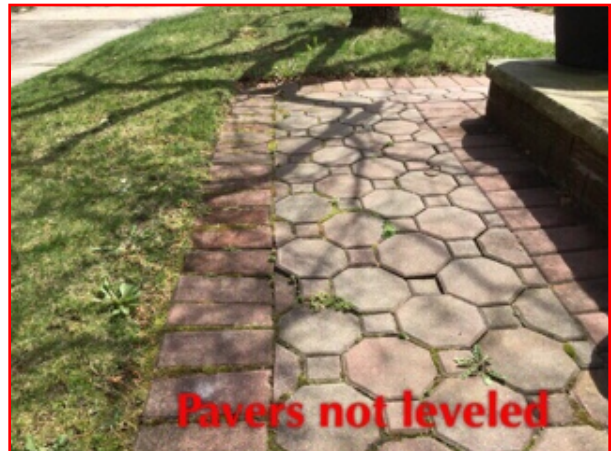
Figure 3-4

2) The front walkway is in marginal condition with defects noted. Salt and snow melting products are the biggest contributors to surface deterioration. Regular maintenance is required to keep the walkway from deteriorating and cracking.

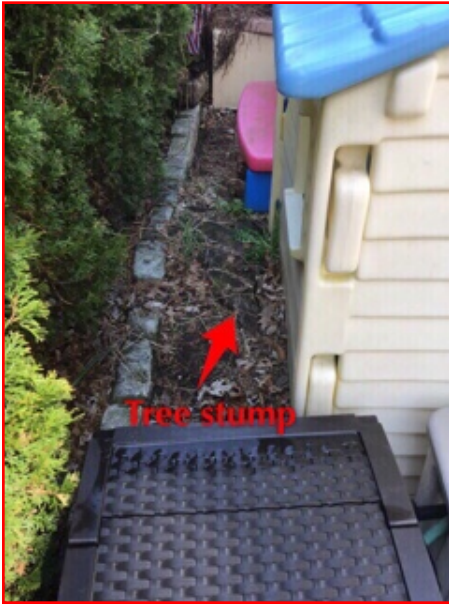
Figure 4-1

3) Tree stump was visible in driveway on day of inspection. Recommend hiring a licensed arborist to further evaluate.

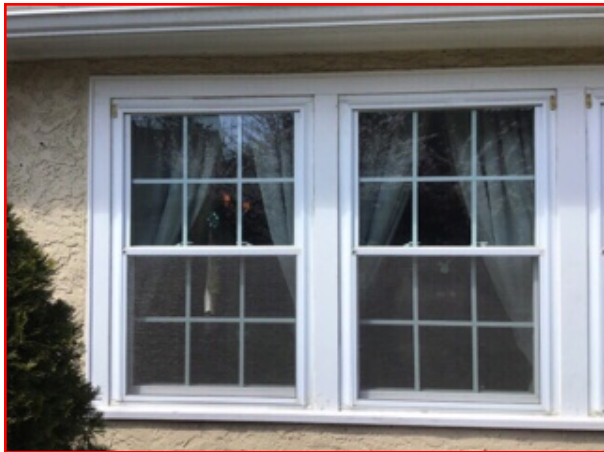
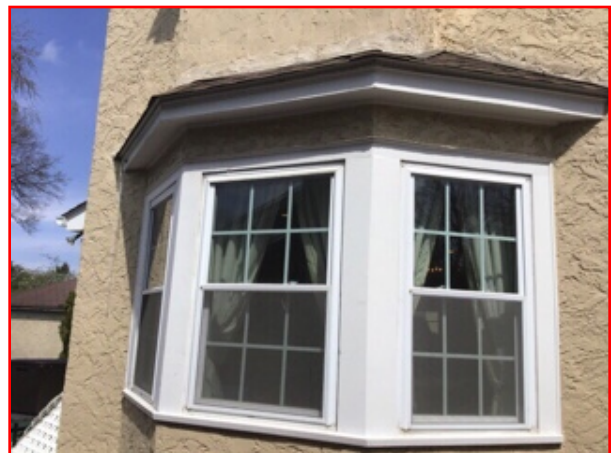
4) The majority of the exterior wood trim of the windows is in poor condition with peeling paint and areas that have started to rot. Recommend hiring a qualified contractor to assess and repair or replace as necessary.

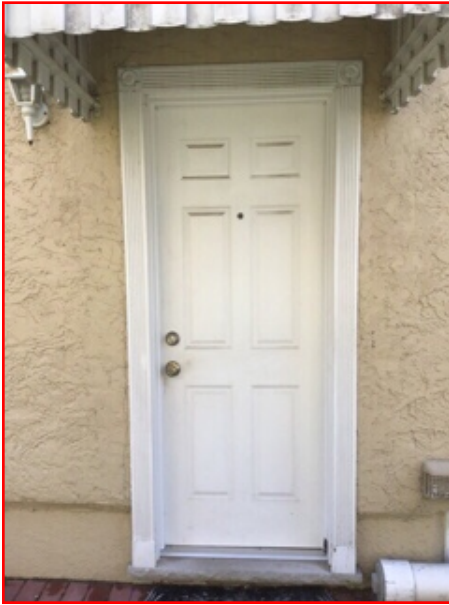
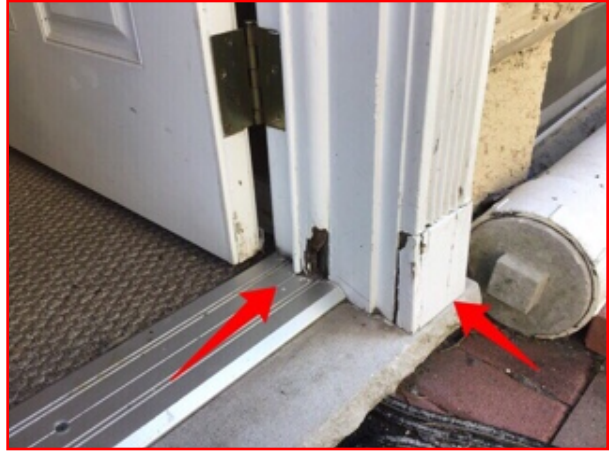
5) The side entry door is in need of repair as there is wood damage at the bottom and it needs sanding and painting. Recommend hiring a qualified contractor to assess and repair as necessary.

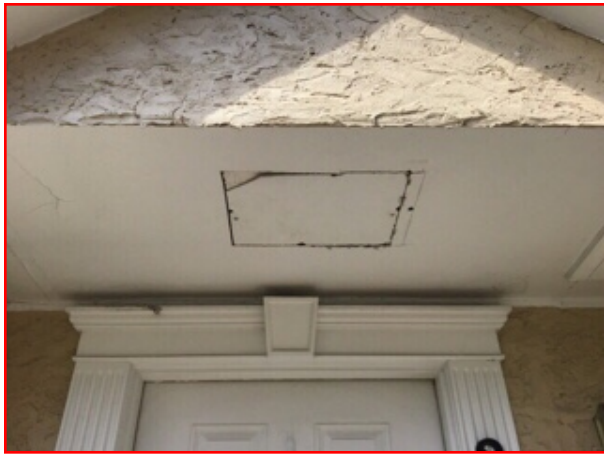
Figure 9-1

6) Over front entrance door noticed on day of inspection a cut out that has not been properly sealed. Recommend hiring a licensed contractor to repair.

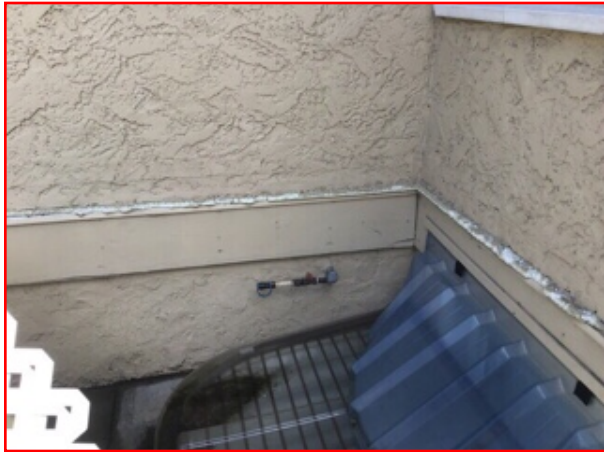
Figure 10-3

7) The exterior stucco has damage. Unable to inspect behind EIF'S (exterior insulation and finish system) to see if there is any water penetration. Have a licensed EIF'S specialist review for possible repair. If water damage is found have reviewed and repaired by a licensed mold contractor.

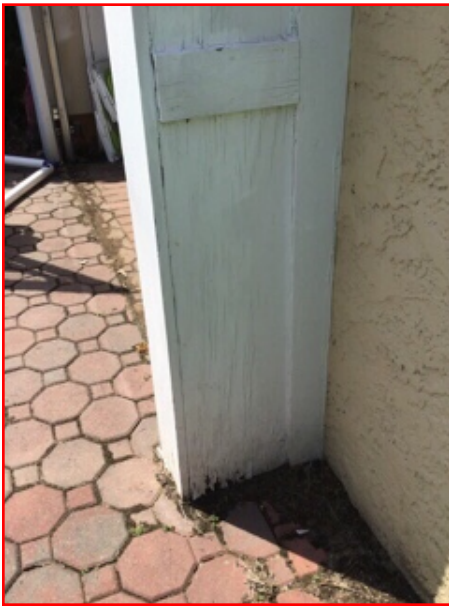
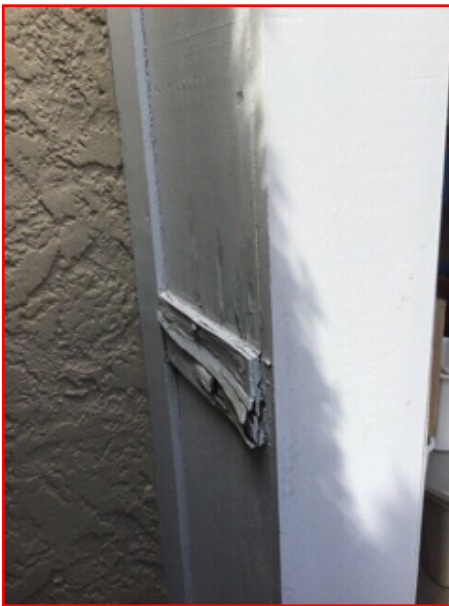
9) The garage door shows deterioration on bottom of side jambs.

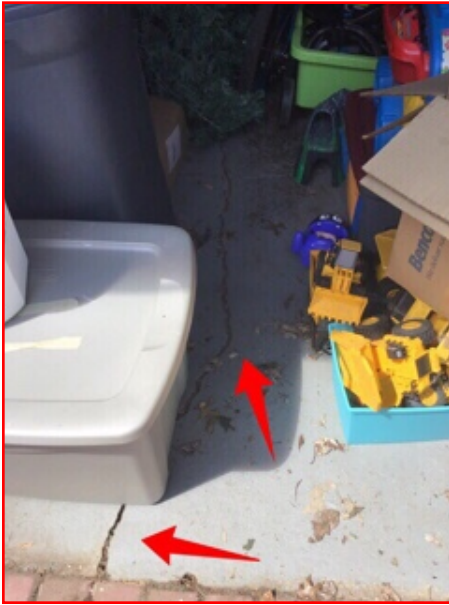
Figure 14-1

10) The floor structure is split or cracked. Need to hire a licensed contractor to further evaluate.

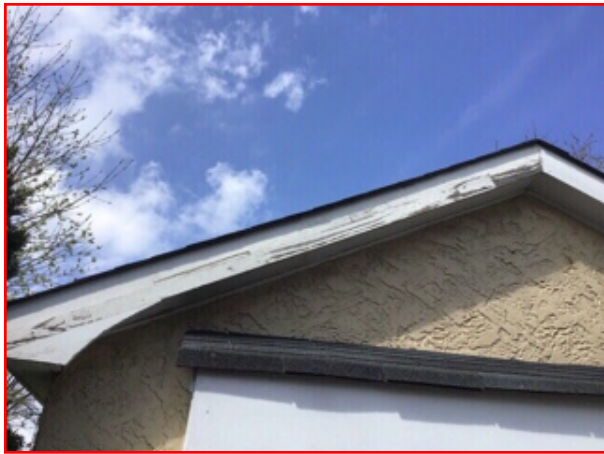
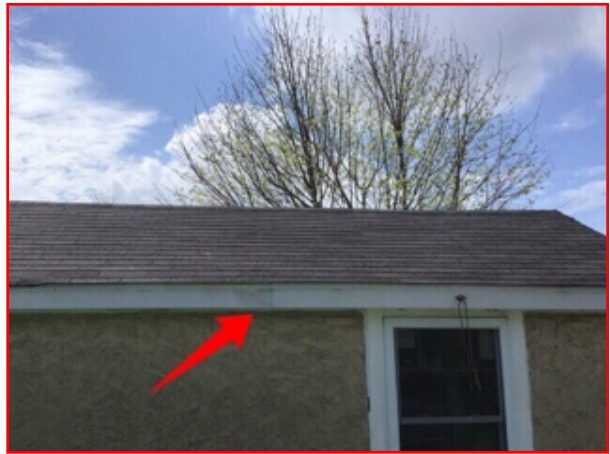
11) The fascias and soffits of the garage are wood and in poor condition with defects noted.

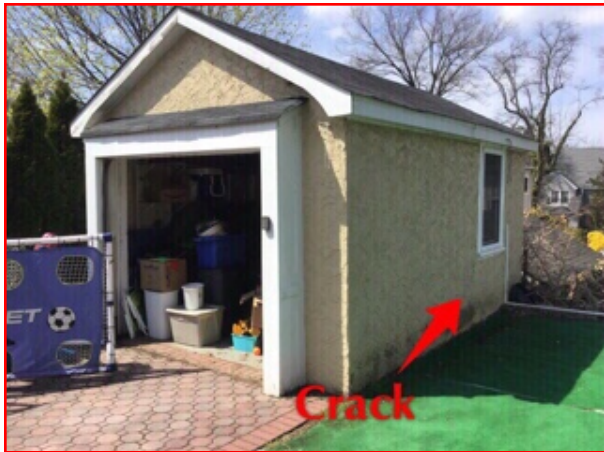
Figure 19-1

13) The side exterior wall was in poor condition with visible crack. Recommend hiring a qualified mason to assess and repair as necessary.

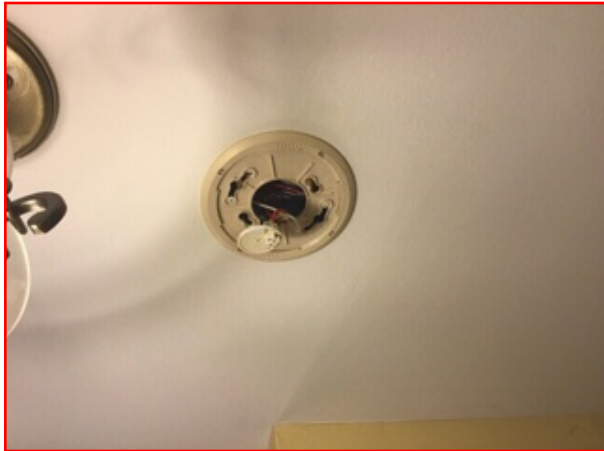
Figure 27-1

17) Smoke and carbon monoxide detectors are important safety devices designed to save lives. It is always recommended to install new detectors when moving into a home if they are 9 volt battery operated. Noticed on day of inspection some smoke detectors are hard wired and missing. Recommend hiring a licensed electrical contractor to evaluate.

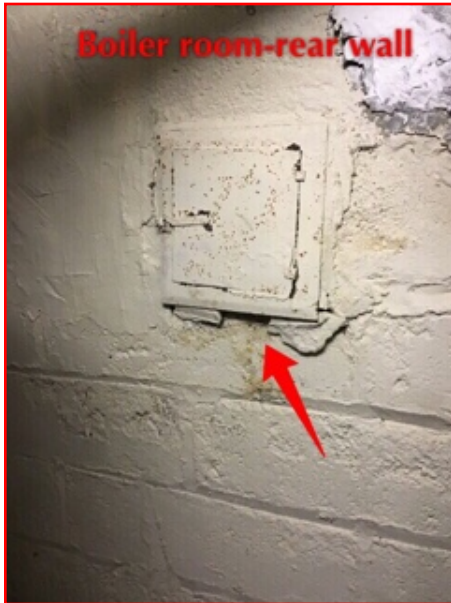
Figure 31-1

18) Clean out in boiler room needs to be properly sealed. Recommend hiring a licensed mason to repair.

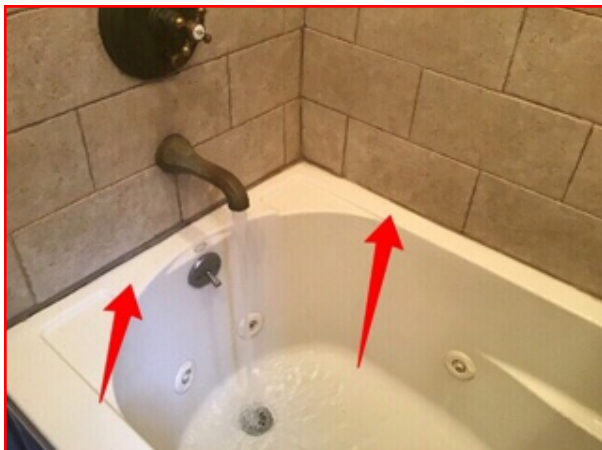
Figure 41-1

20) Bathroom on the second floor needs recaulking in tub area. Recommend hiring a licensed contractor to further evaluate.

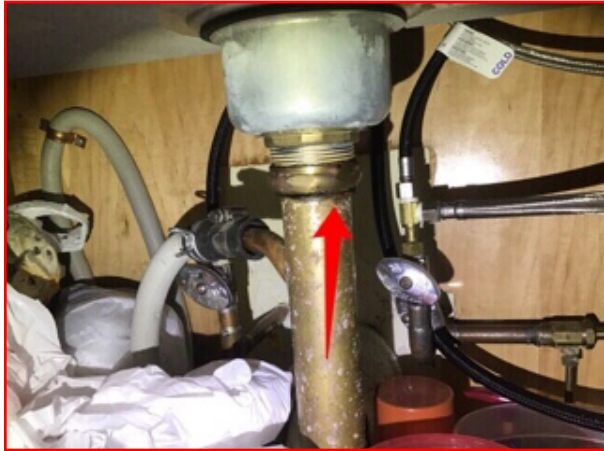
Figure 43-1

21) The waste pipe under the sink shows signs of corrosion. Recommend hiring a licensed plumber to further evaluate.

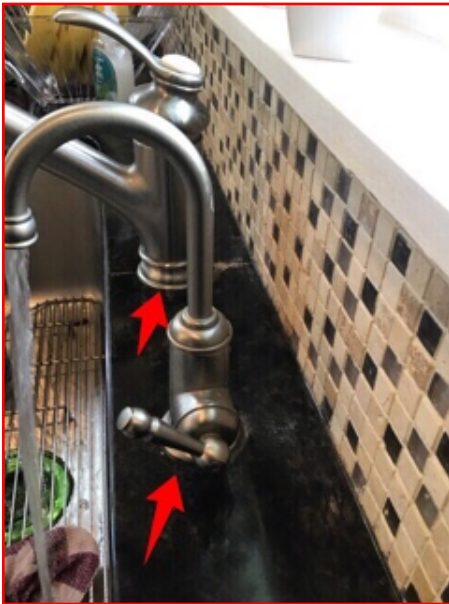
Figure 44-1

22) The kitchen faucet leaks around mount. Recommend hiring licensed plumber to further evaluate.

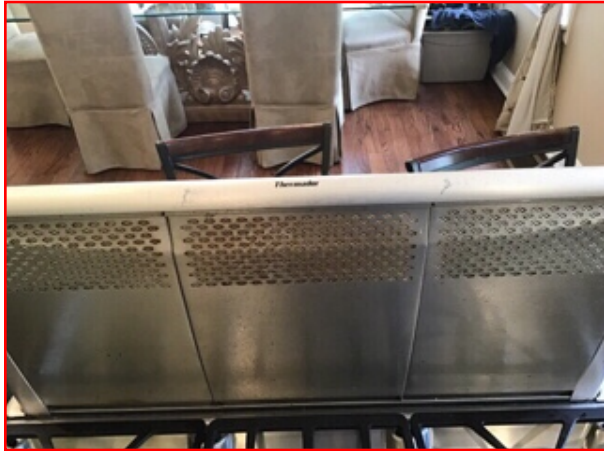
Figure 46-1

23) On day of inspection, retractable stove top exhaust was not working properly. Recommend hiring a appliance repair company for further inspection.

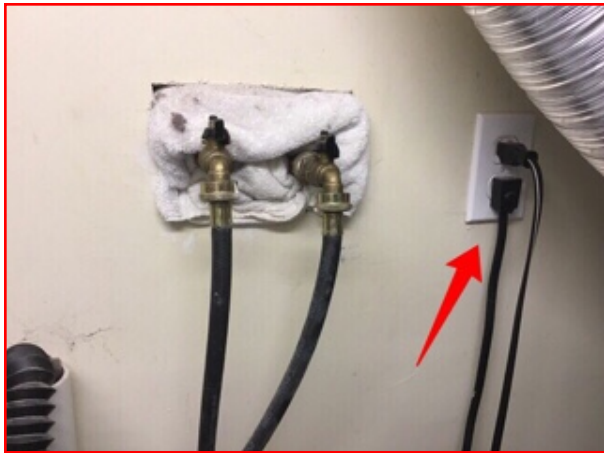
Figure 48-1

24) The outlet in the laundry area was not a GFCI outlet and is a safety hazard as it is directly below/next to the water supply lines. Recommend hiring a licensed electrician to replace the existing outlet with a GFCI outlet as necessary.

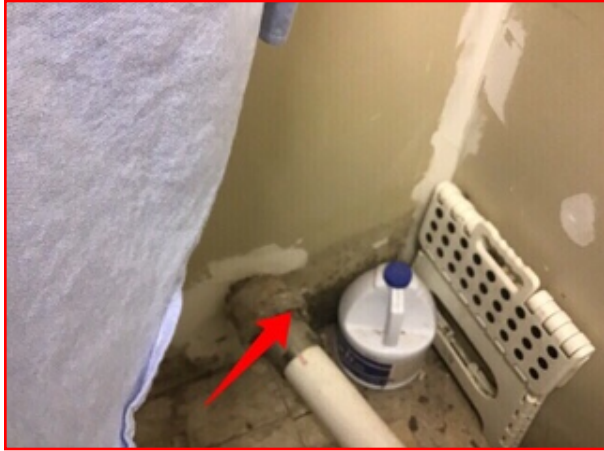
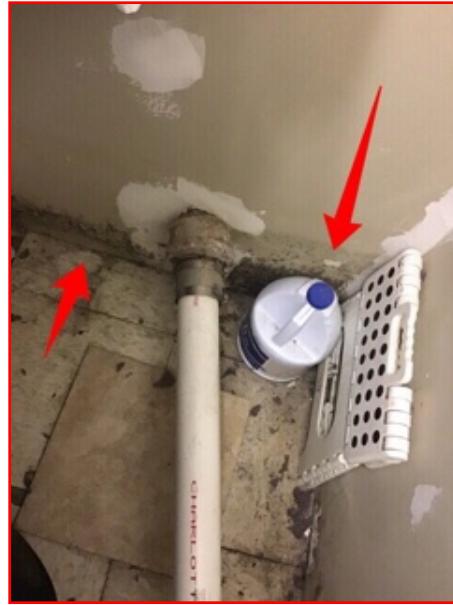
25) Possible signs of mold in laundry room . Recommend hiring a licensed mold inspector to further evaluate.

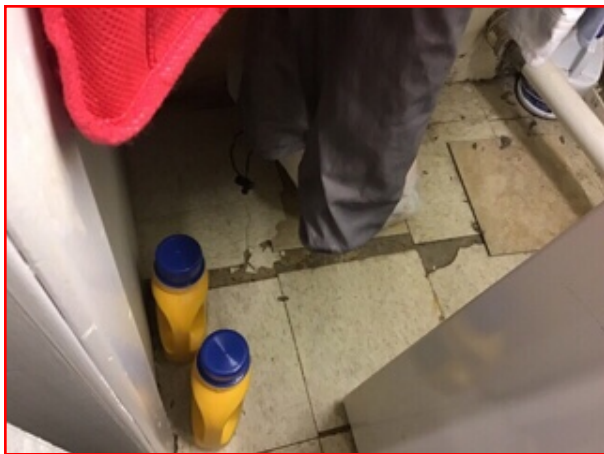
Figure 50-1

26) Laundry room has loose floor tiles. Recommend hiring a licensed contractor to repair.

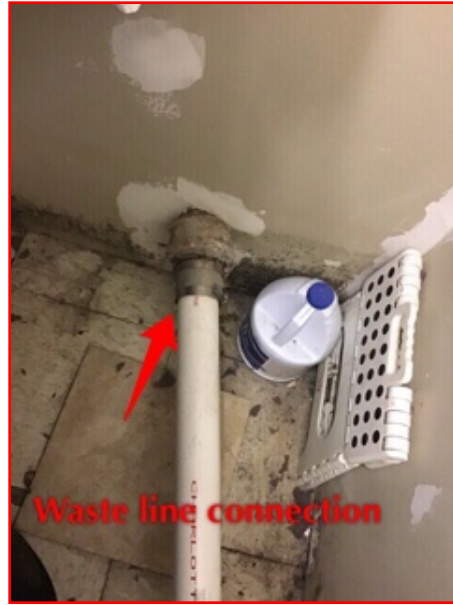
Figure 51-2

27) The washing machine drain line is not properly secure. Signs of possible leak. Recommend hiring a licensed plumber for further evaluation.

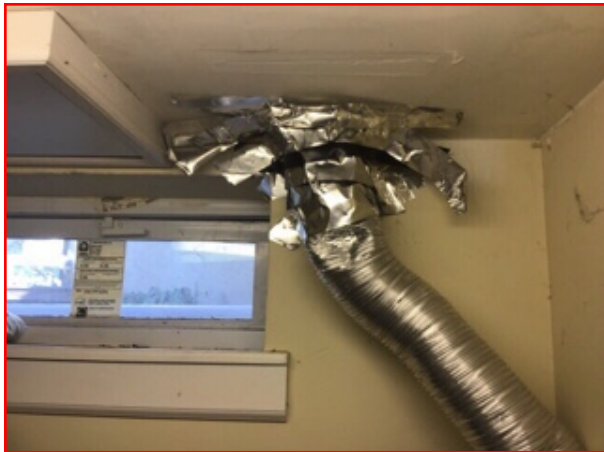
Figure 52-1

28) The dryer exhaust vent is not installed properly and not properly vented out to the exterior. This needs immediate attention. Do not recommend operating dryer until a licensed contractor further evaluates.

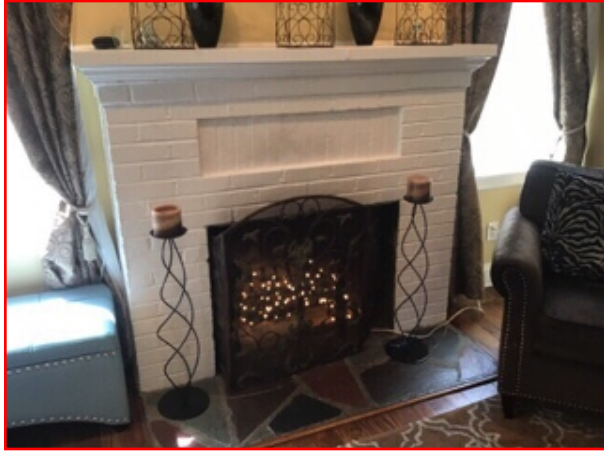
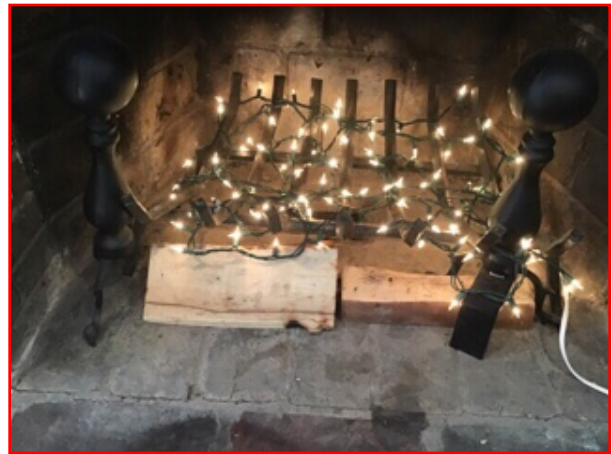
29) The fireplace is in marginal condition . It is ALWAYS recommended to have the flue inspected and cleaned prior to use. Recommend hiring a qualified chimney company to assess and repair as necessary. Damper was not tested on day of inspection.

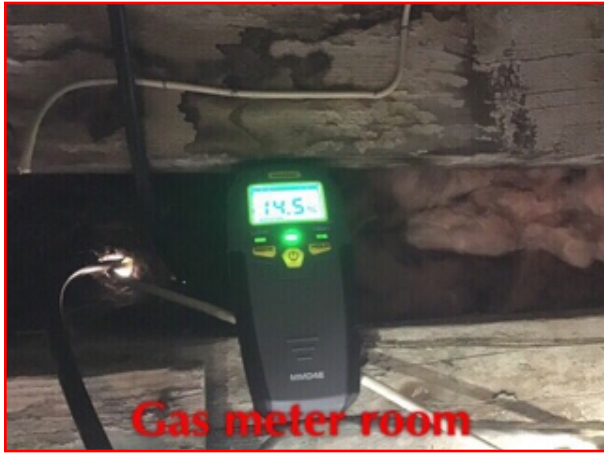
Figure 55-1

30) The basement has signs of moderate moisture and dampness. Structure and framing appear to be proper and to the building methods of the time it was built. Recommend hiring a qualified basement waterproofing contractor to assess and recommend a proper drainage system or repair as necessary.

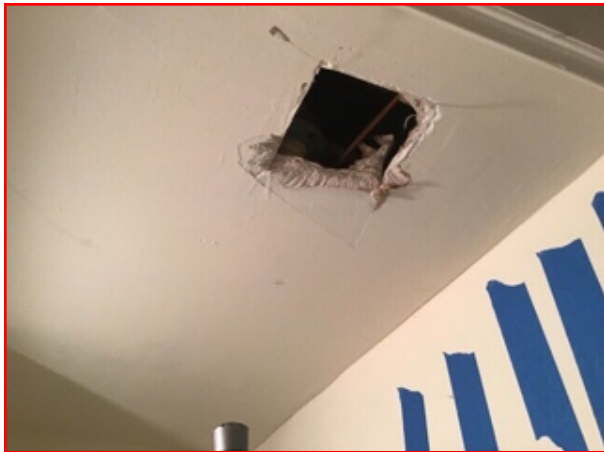
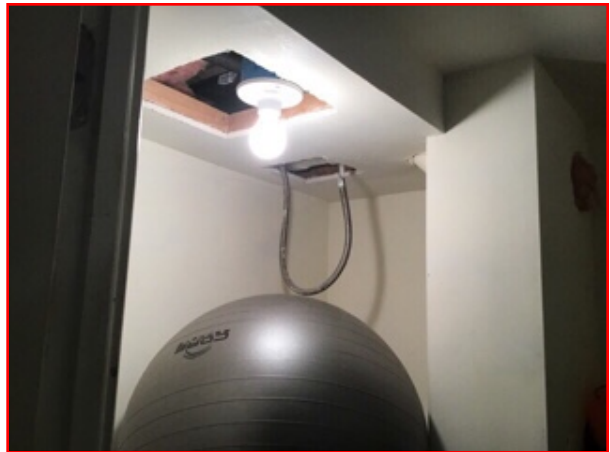
31) The ceiling in the storage closet in the basement needs repair. Recommend hiring a licensed contractor to repair.

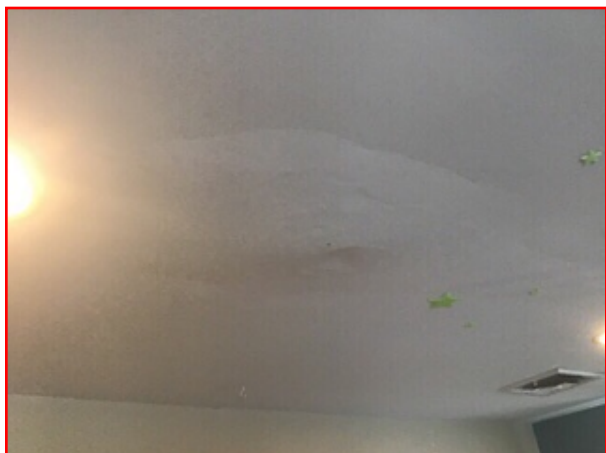
Figure 57-1

32) The ceiling is peeling as a result from water leak above. Recommend hiring a licensed contractor for further evaluation.
