# Ground Up Home Inspections

Inspected By: Manny Theocharidis. Lic # 16000098512

## Residential Inspection Report

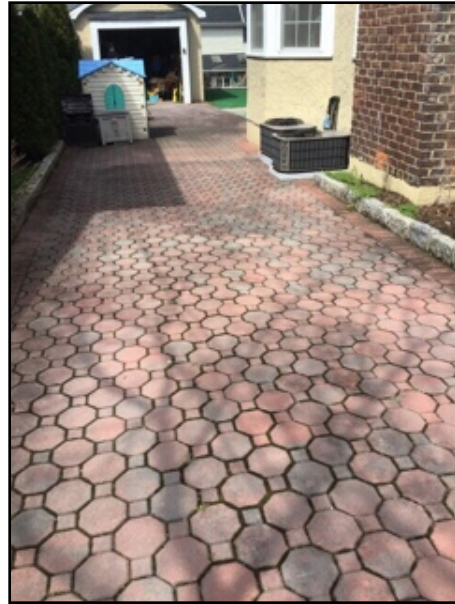
Figure 2-2

The property appears to not be graded properly to allow rain water and melting snow to divert away from the structure when there is a normal amount of precipitation. Recommend monitoring areas around the foundation within 6' for ruts and depressions where areas of water can collect and pool.

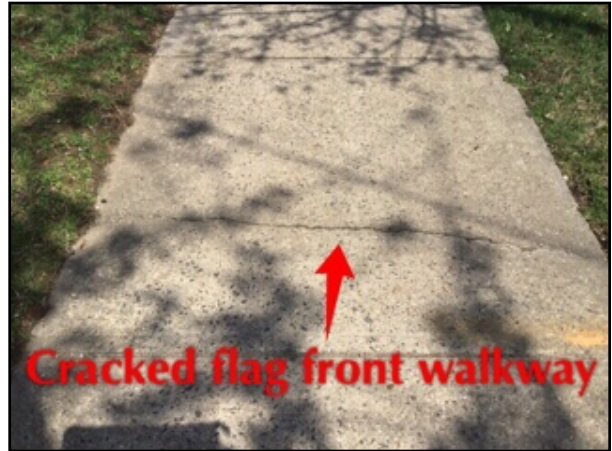
Figure 3-2

The front walkway is in marginal condition with defects noted. Salt and snow melting products are the biggest contributors to surface deterioration. Regular maintenance is required to keep the walkway from deteriorating and cracking.

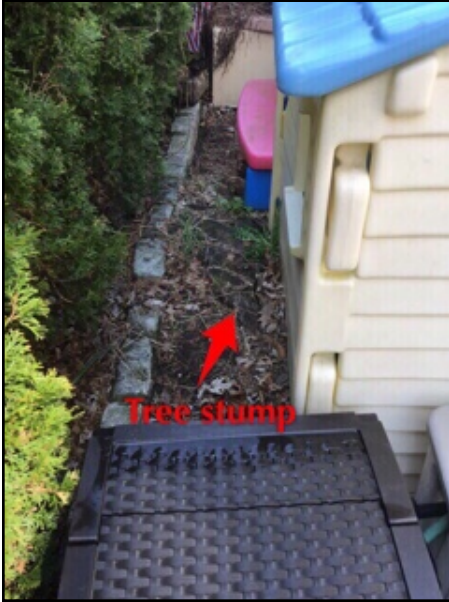
Figure 4-1

Tree stump was visible in driveway on day of inspection. Recommend hiring a licensed arborist to further evaluate.

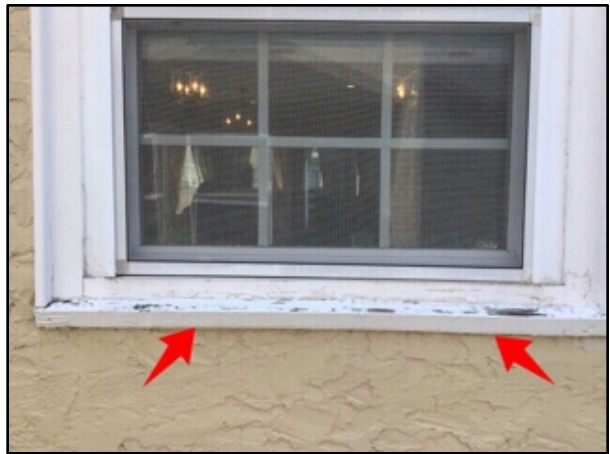
Figure 5-2

The majority of the exterior wood trim of the windows is in poor condition with peeling paint and areas that have started to rot. Recommend hiring a qualified contractor to assess and repair or replace as necessary.

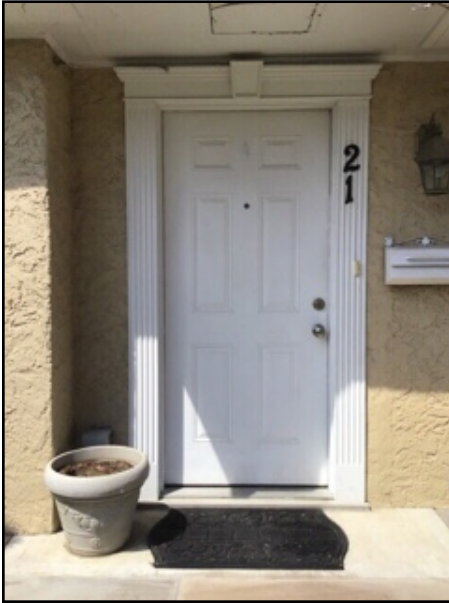
Figure 6-1

The front entry door is in good condition with no defects noted.

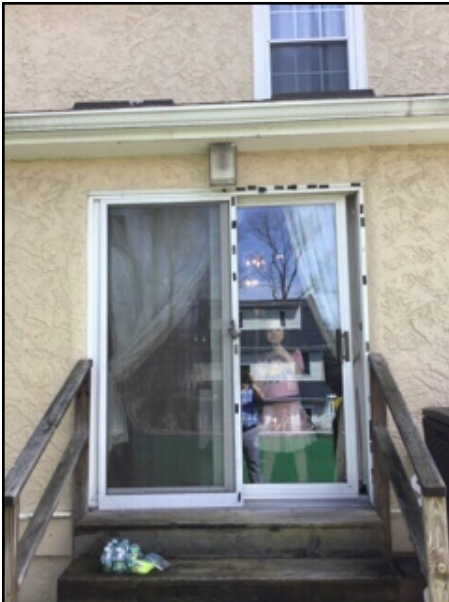
Figure 7-1

The rear entry door is in good condition with no defects noted. The screen/storm door was operational and in working condition on the day of inspection.

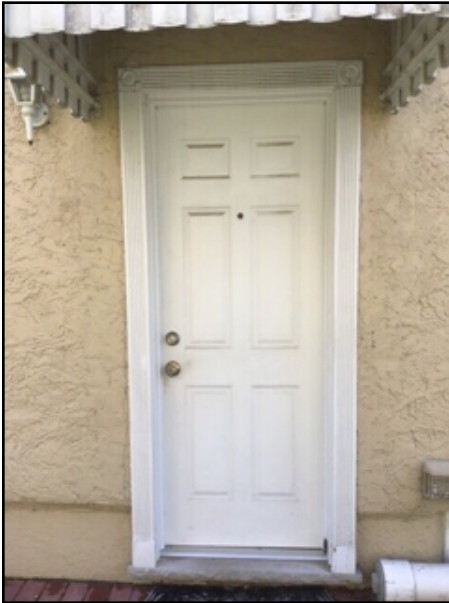
Figure 8-1

The side entry door is in need of repair as there is wood damage at the bottom and it needs sanding and painting. Recommend hiring a qualified contractor to assess and repair as necessary.

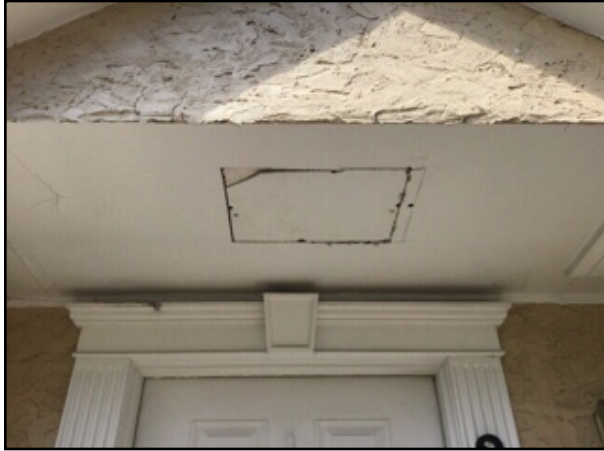
Figure 9-1

Over front entrance door noticed on day of inspection a cut out that has not been properly sealed. Recommend hiring a licensed contractor to repair.

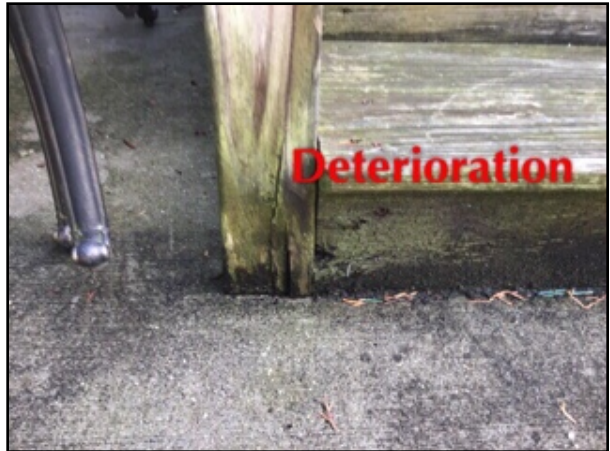
Figure 11-2

The rear steps are in an unsafe condition as they are loose and deteriorating. Recommend hiring a qualified contractor to assess and repair as necessary.

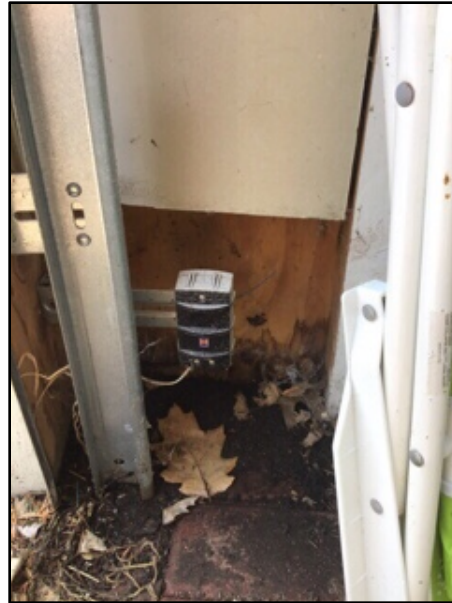
Figure 12-2

The garage door shows deterioration on bottom of side jambs.

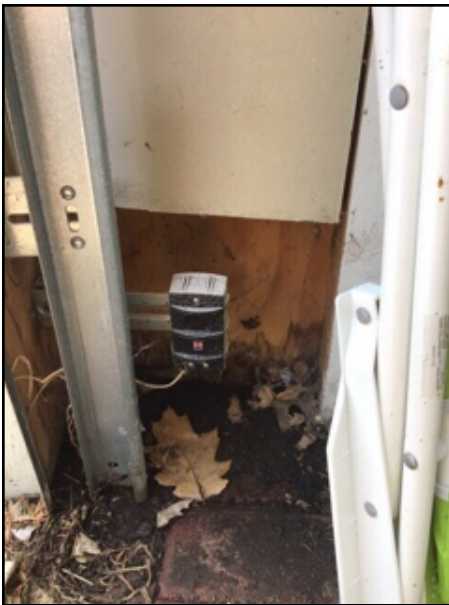
Figure 13-1

The garage door openers worked properly on day of inspection. The auto reverse safety feature worked properly on day of inspection.

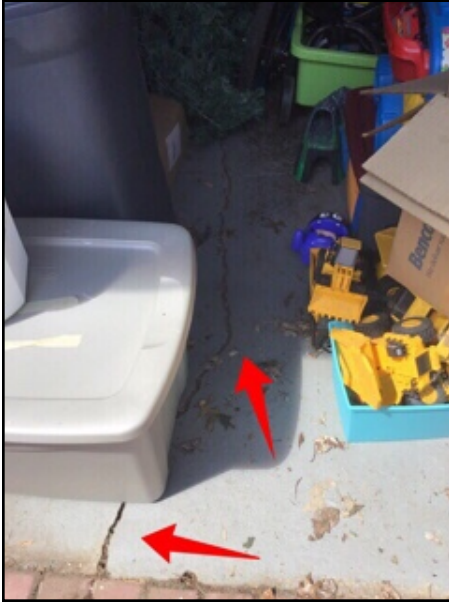
Figure 14-1

The floor structure is split or cracked. Need to hire a licensed contractor to further evaluate.

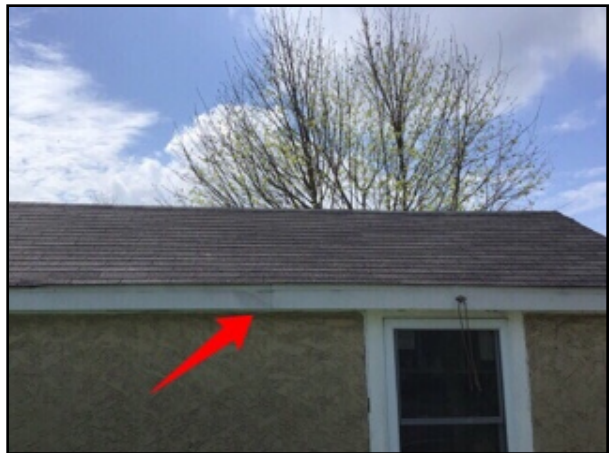
Figure 15-2

The fascias and soffits of the garage are wood and in poor condition with defects noted.

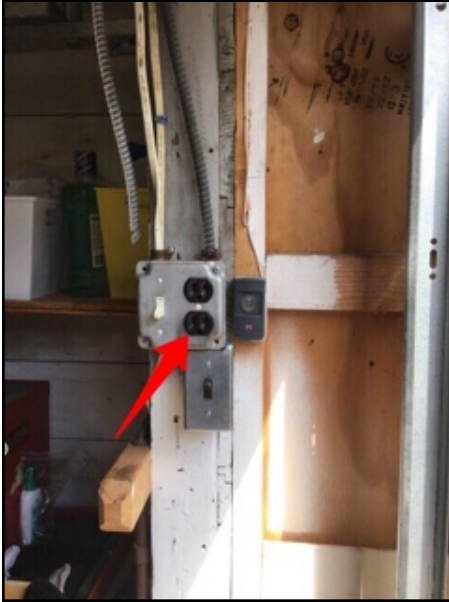
Figure 16-1

**Comment 16:**  
Need to replace outlet with GFCI receptacle. Recommend hiring a licensed electrical contractor to repair.

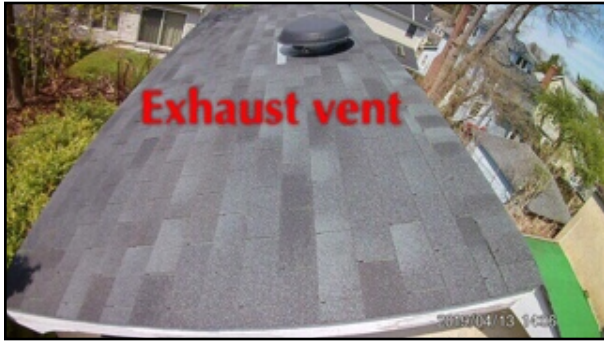
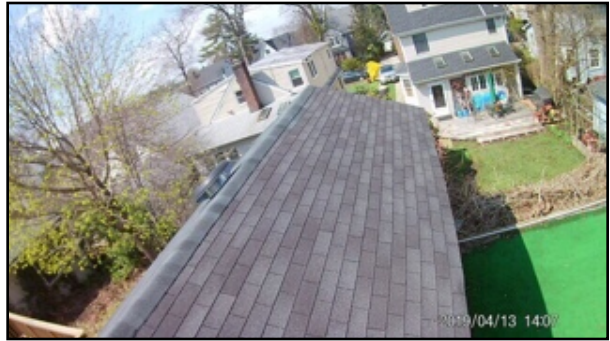
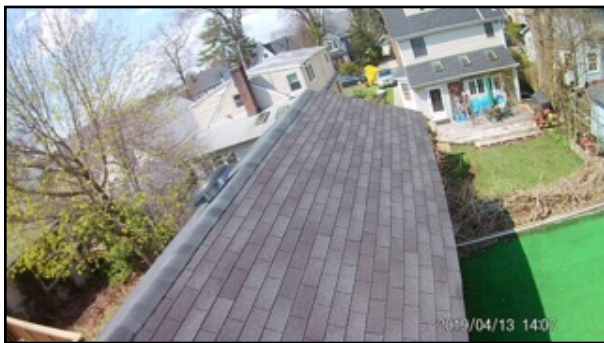
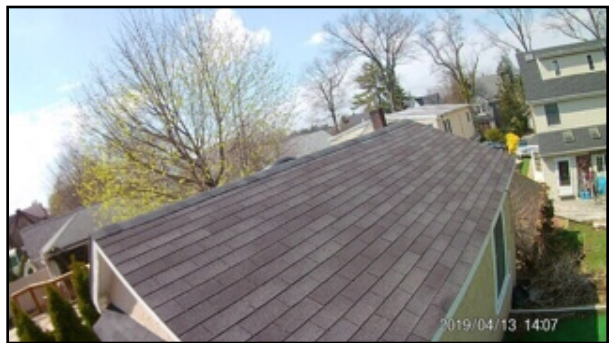
The garage roof is comprised of 3 tab asphalt shingles with no major defects noted. The roof is between 3-8 years old and is rated for a 25 year life expectancy. Venting was proper with gable vents and doors/windows and no signs of moisture or water penetration were noted at the ceiling.

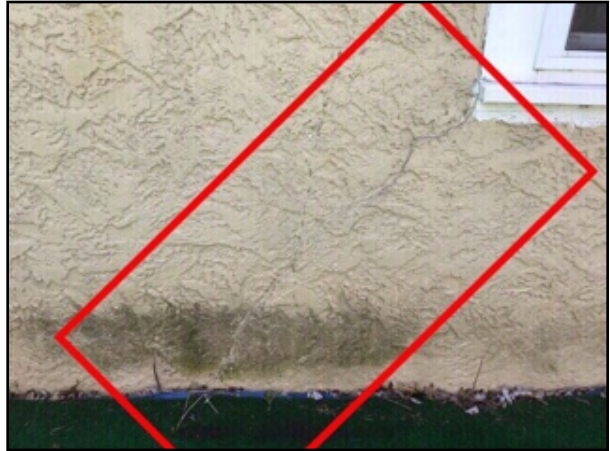
Figure 19-2

The side exterior wall was in poor condition with visible crack. Recommend hiring a qualified mason to assess and repair as necessary.

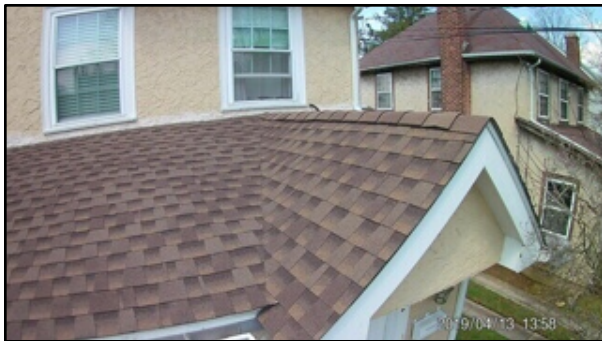
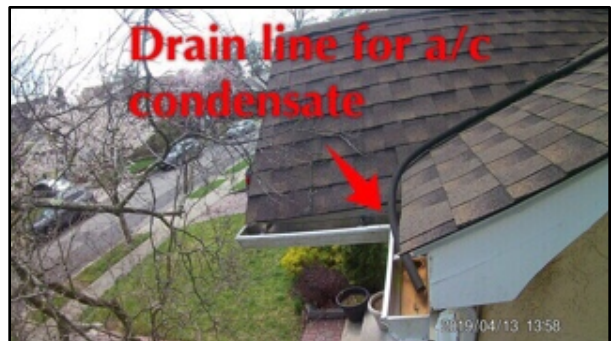
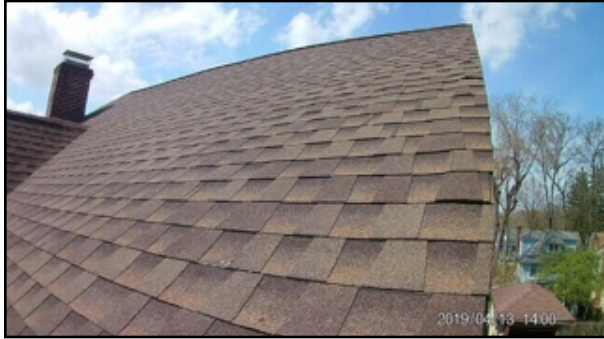
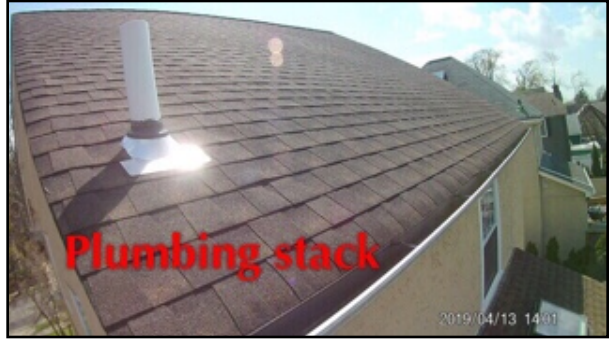
The roof is comprised of architectural asphalt shingles with no major defects noted. These shingles are rated for 35 to 45 years of life expectancy and at the present time are in good condition.

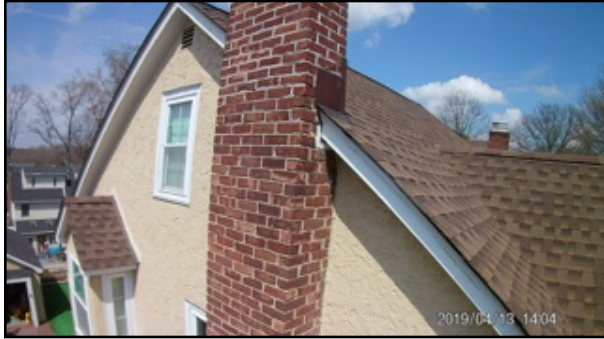
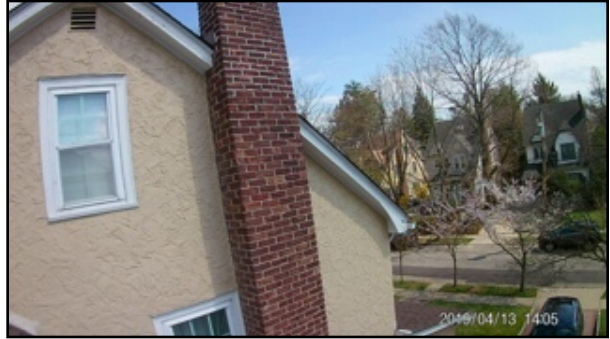
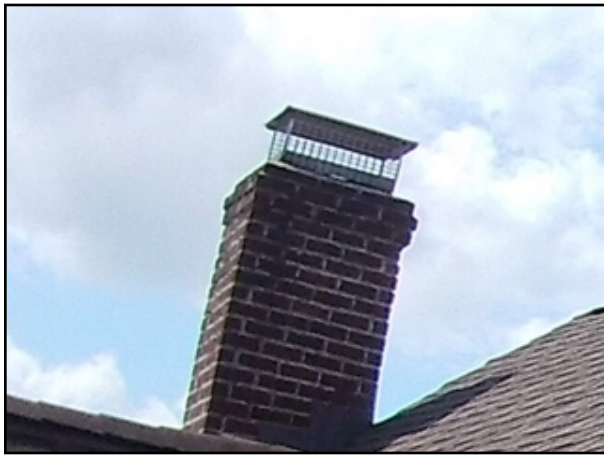
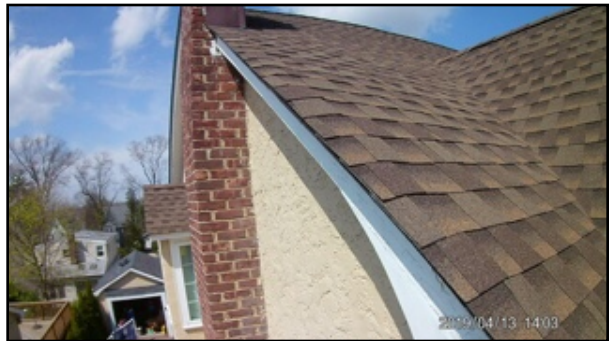
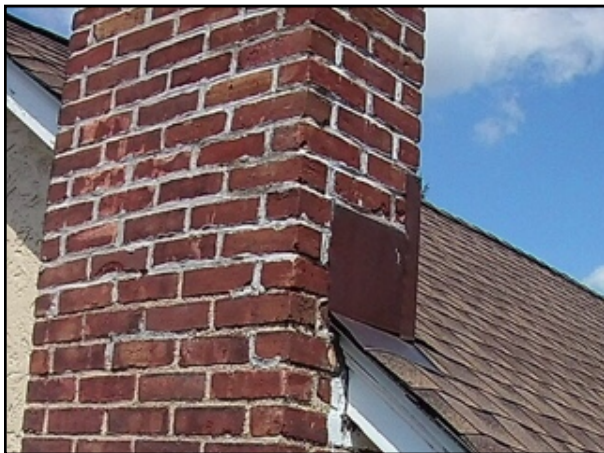
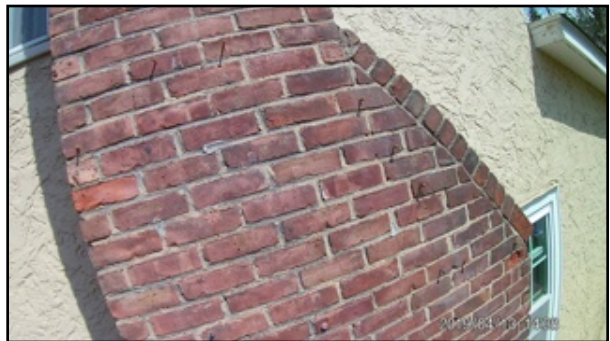
The chimney is in need of re-pointing at the top rows as there is signs of deterioration in the mortar joints. Also, there is a proper spark arrestor at the top of the chimney flue which is needed for a fireplace. Recommend hiring a qualified mason to repair as necessary, check the rain cap when he is re-pointing and repairing the chimney.

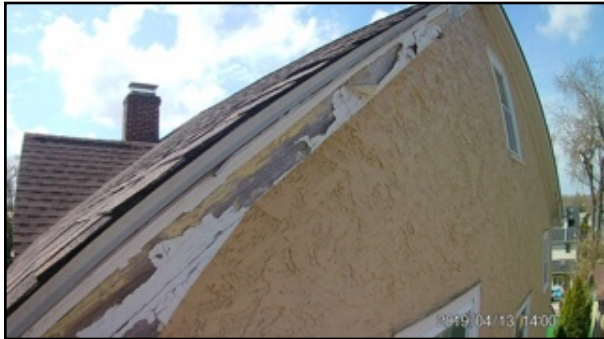
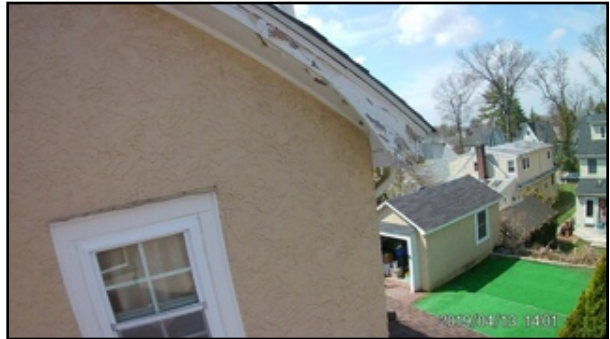
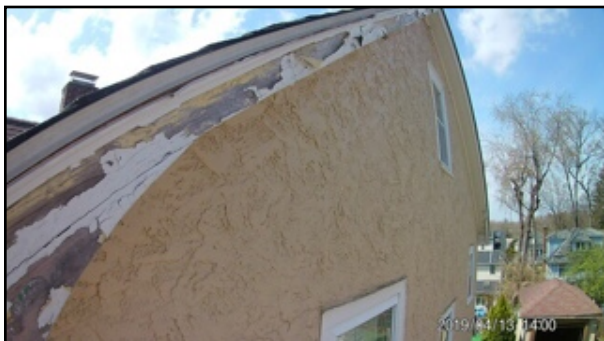
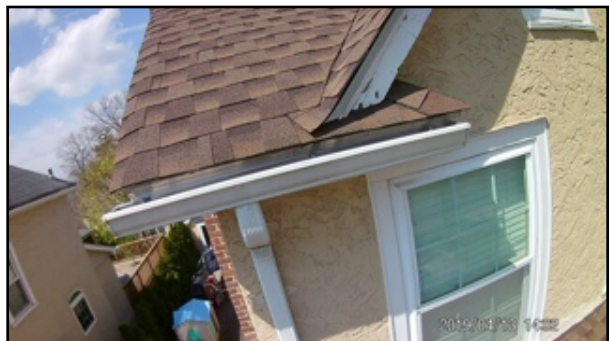
The fascias and soffits are wood and are damaged and rotted in numerous places as well as having cracked and peeling paint. Recommend hiring a qualified contractor to assess and repair or replace all defects as necessary.

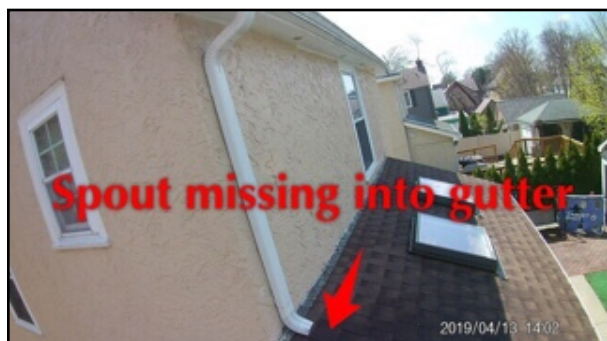
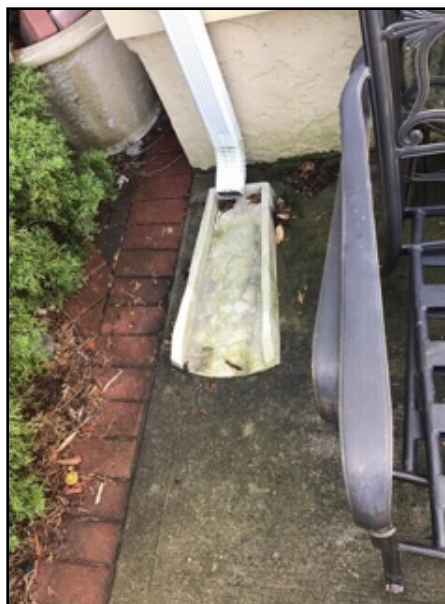
The gutters on the house are missing in numerous areas. Recommend hiring a qualified contractor to assess and install proper gutters, leaders and extensions as necessary.

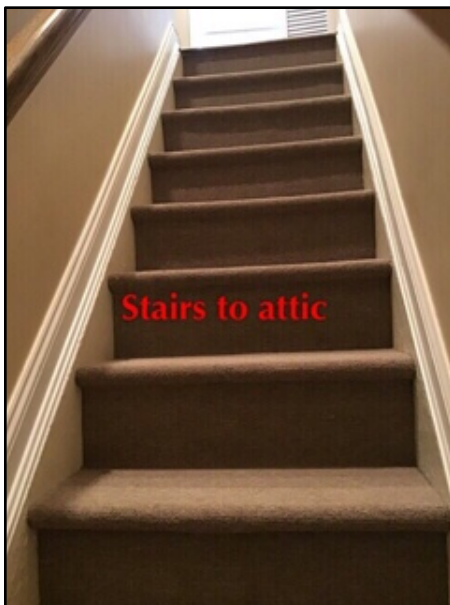
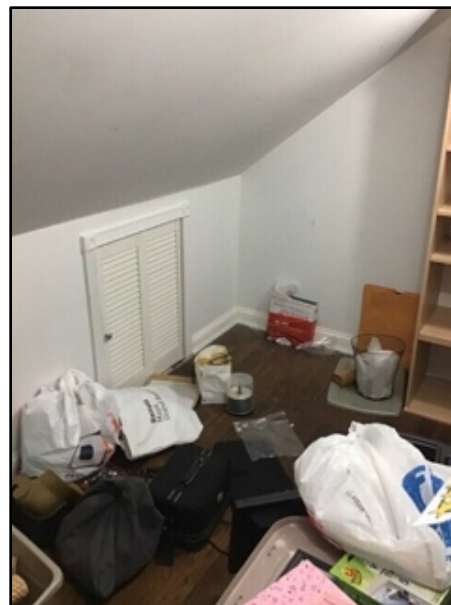
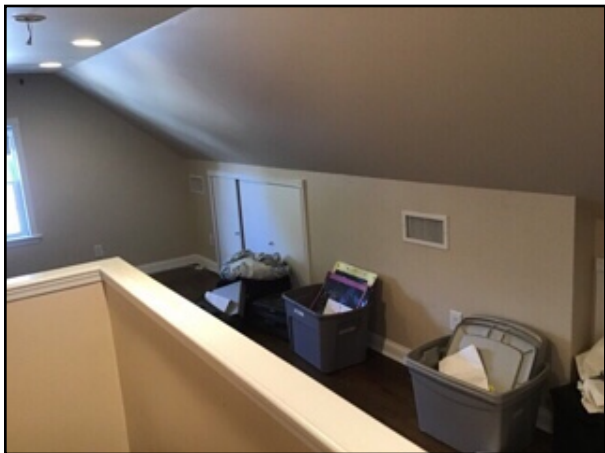
The attic was fully finished and in good condition with no leaks or signs of moisture or mold.

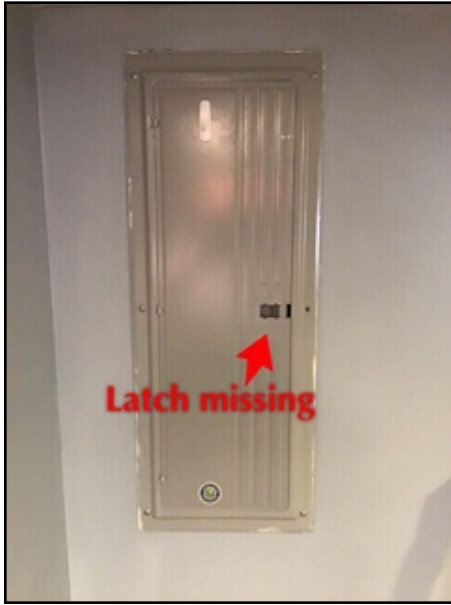
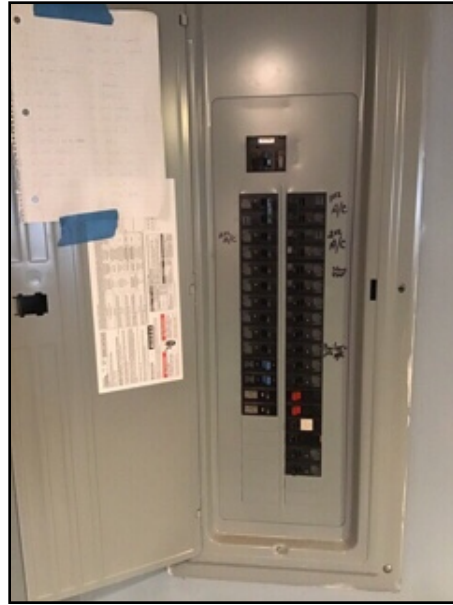
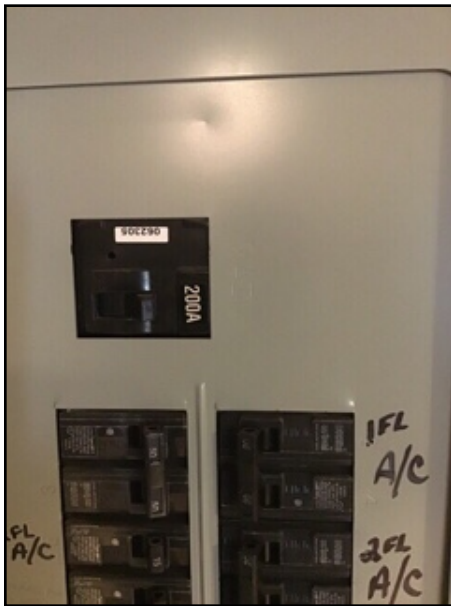
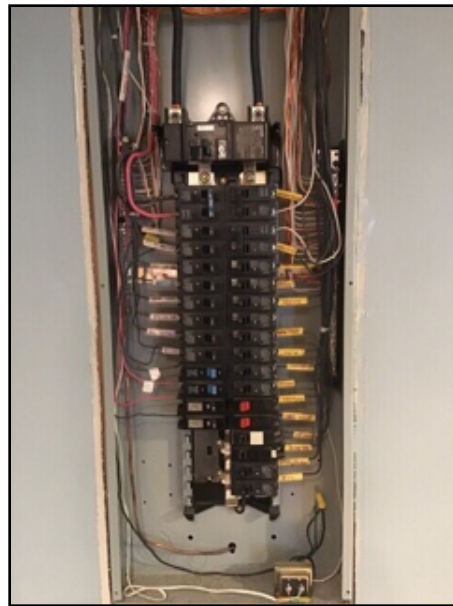
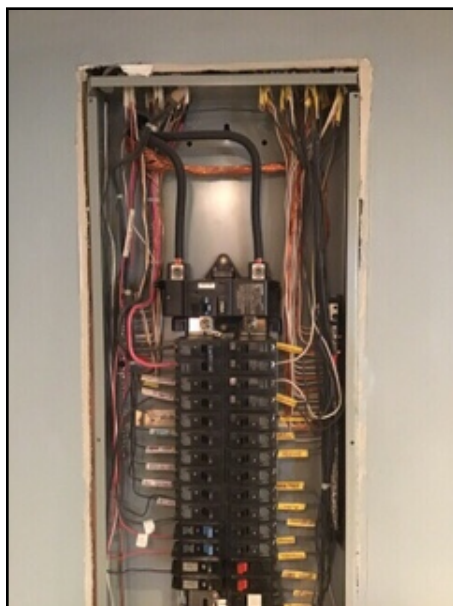
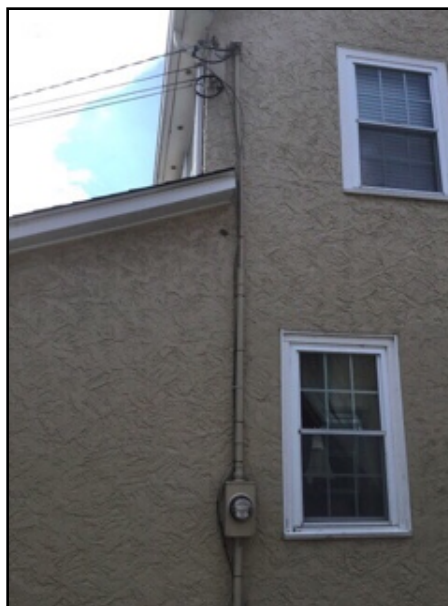
The electrical service is overhead and to a meter on the side of the house. The electric panel was located in the basement and is 200 amp main service. The panel was in good condition with no defects noted and grounding was proper. There were no double taps or missing covers and there was additional room for expansion.

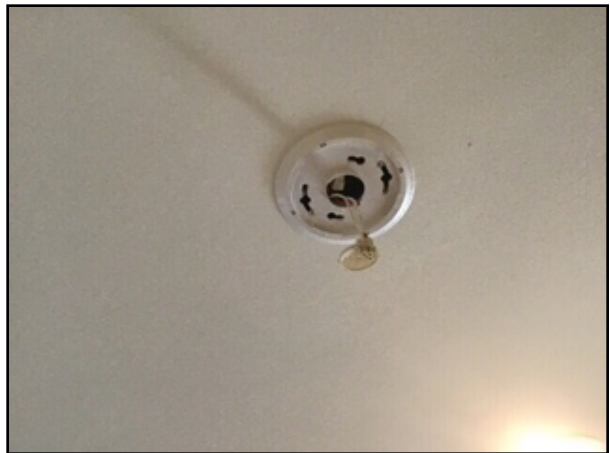
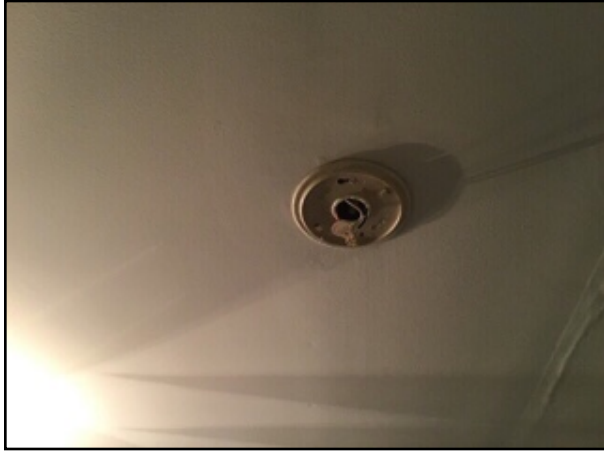
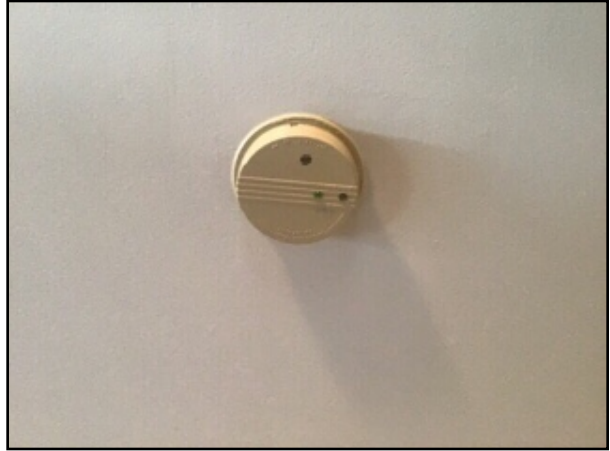
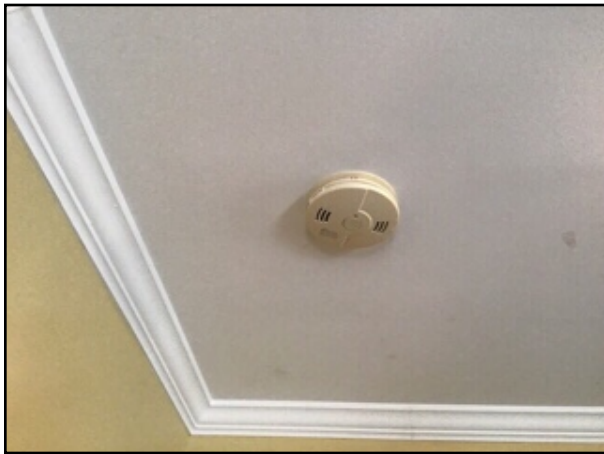
Smoke and carbon monoxide detectors are important safety devices designed to save lives. It is always recommended to install new detectors when moving into a home if they are 9 volt battery operated. Noticed on day of inspection some smoke detectors are hard wired and missing. Recommend hiring a licensed electrical contractor to evaluate.

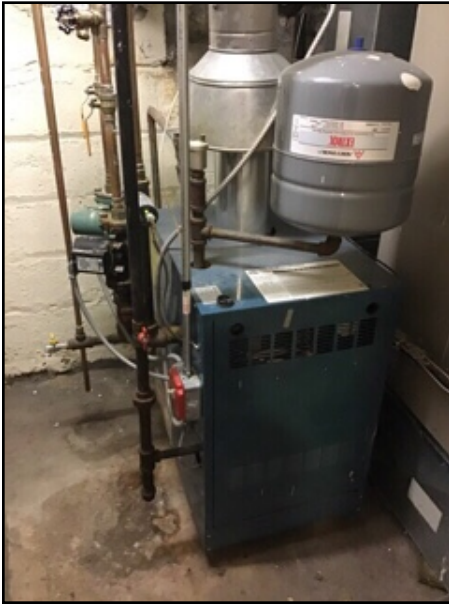
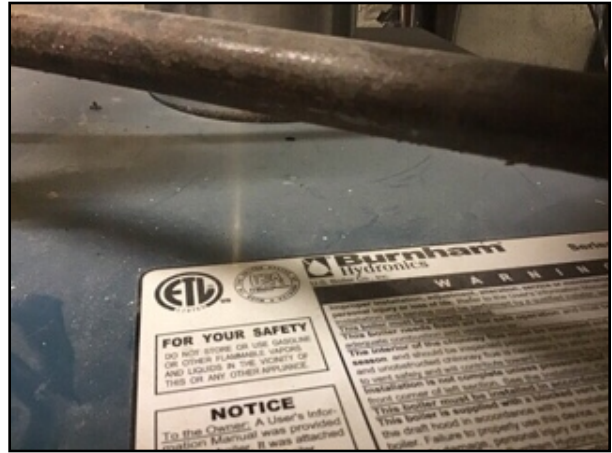
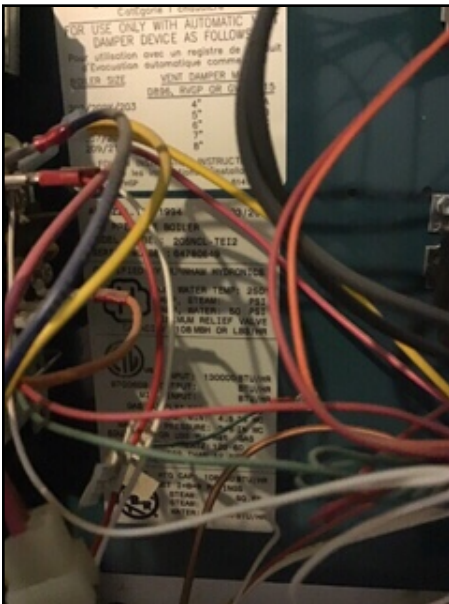
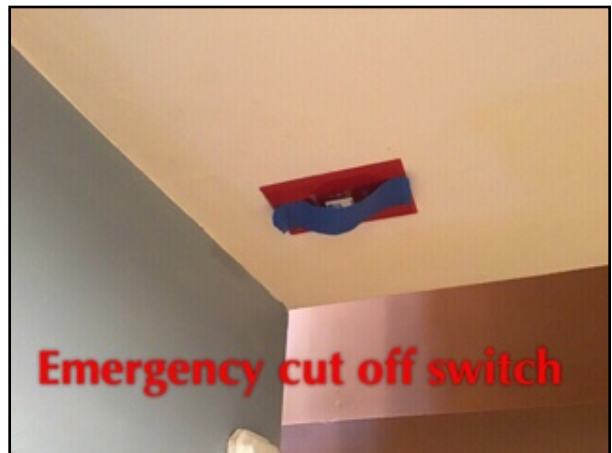
The heating system is a gas furnace made by Burnham. The unit is in good condition and appears to have been maintained properly over the years. The heating system was tested and worked on day of inspection.

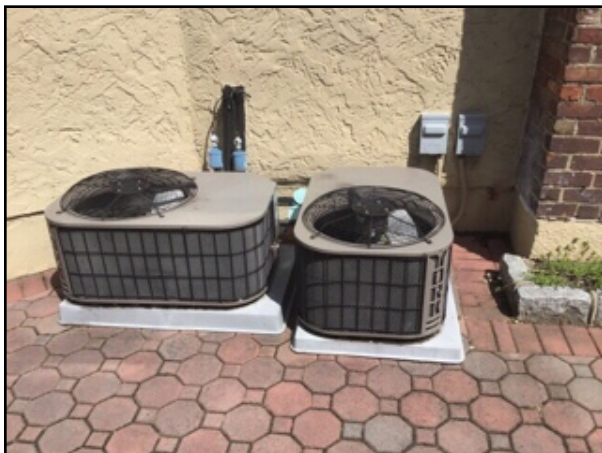
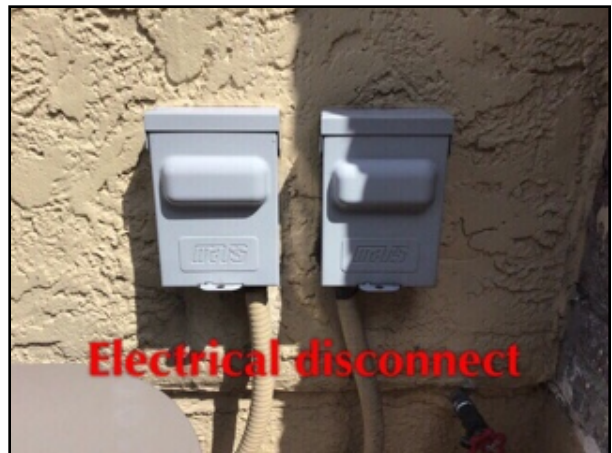
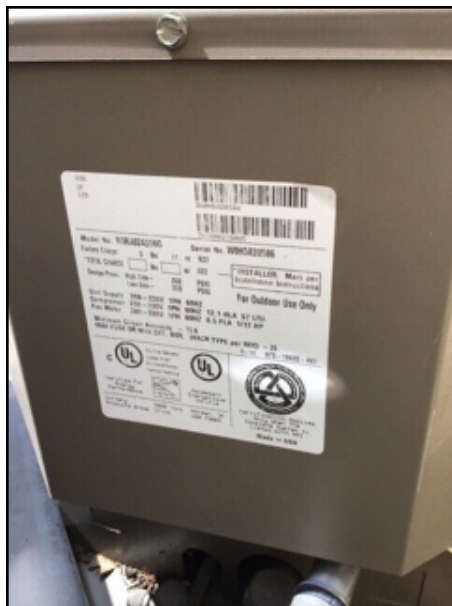
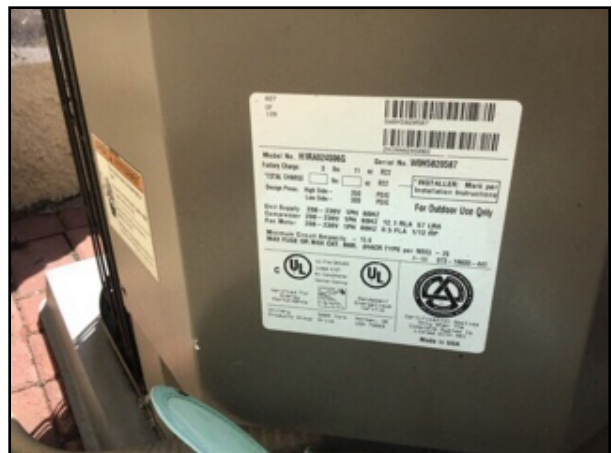
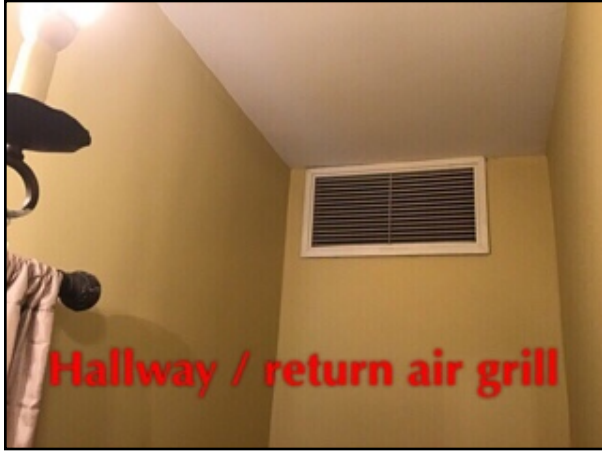
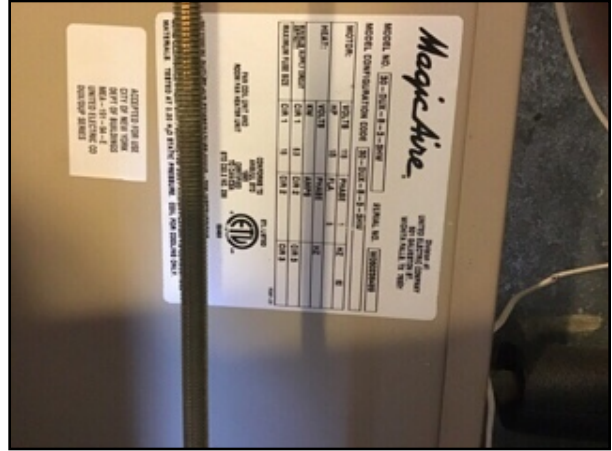
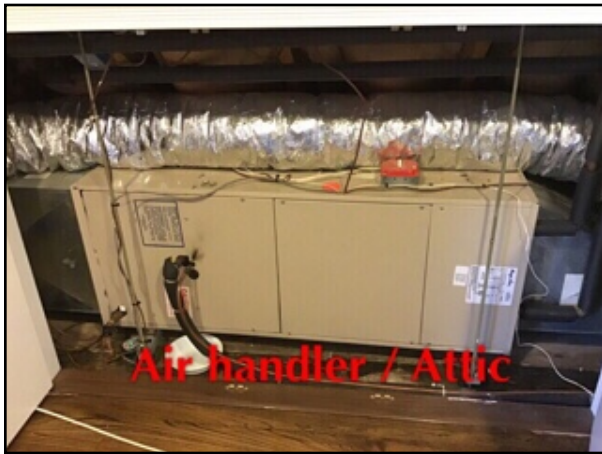
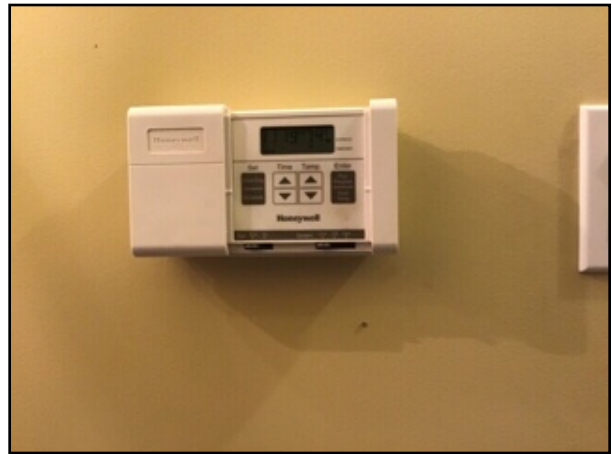
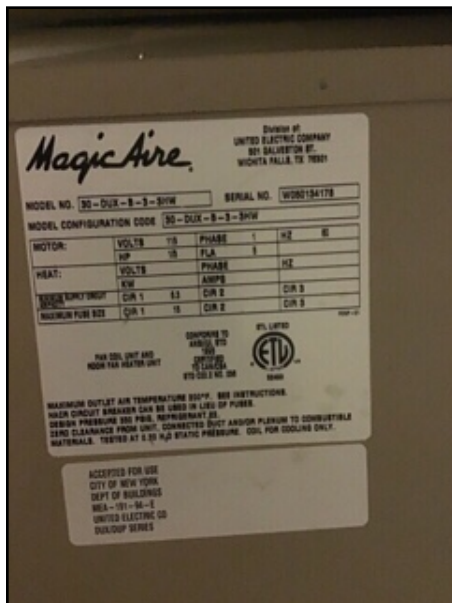
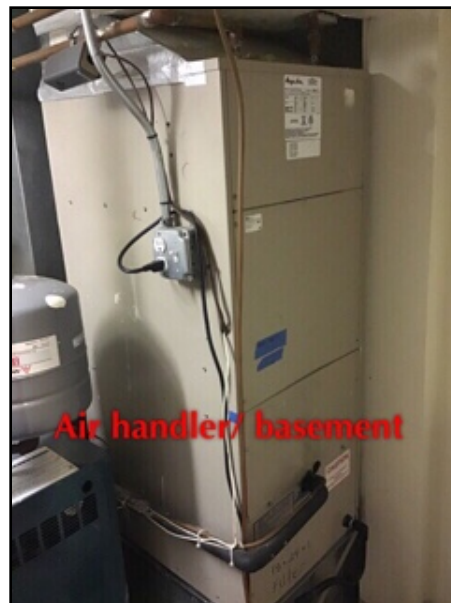
**Comment 32:**

The air conditioning system was tested and operated properly on the date of inspection. No major defects were noted and it is recommended to have proper servicing done annually to ensure maximum efficiency. The refrigerant lines and electrical disconnects were noted and in good condition.

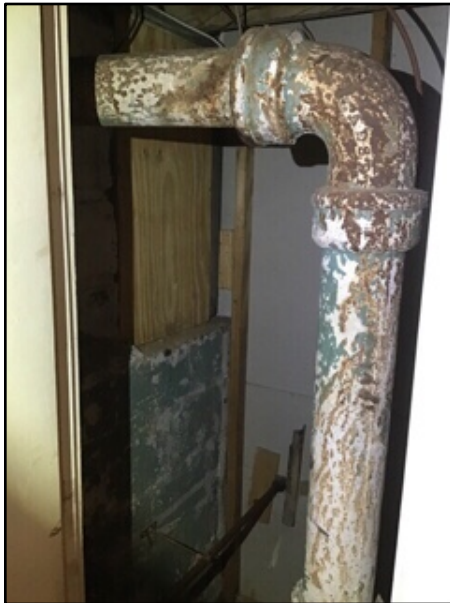
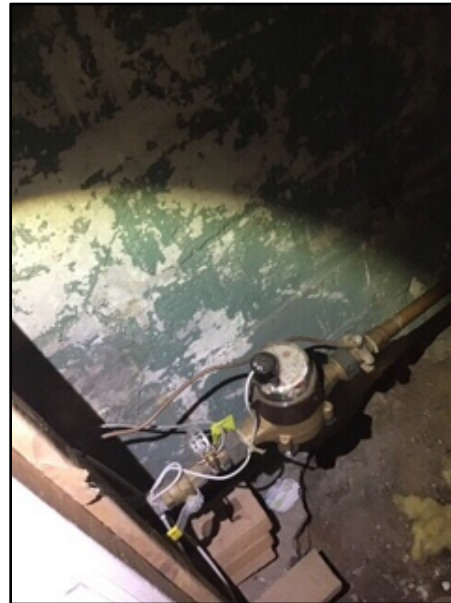
## Comment 33:

The plumbing system in the house consists of public water and sewer systems. The water was run through all fixtures for 30 minutes and there were no leaks noted on the supply or drain sides, and no major defects were noted. The main sewer pipe was cast iron and all the visible supply lines are copper pipe. Numerous drain and water lines were not visible due to the basement being finished but no leaks were noticed at or on the basement ceiling.

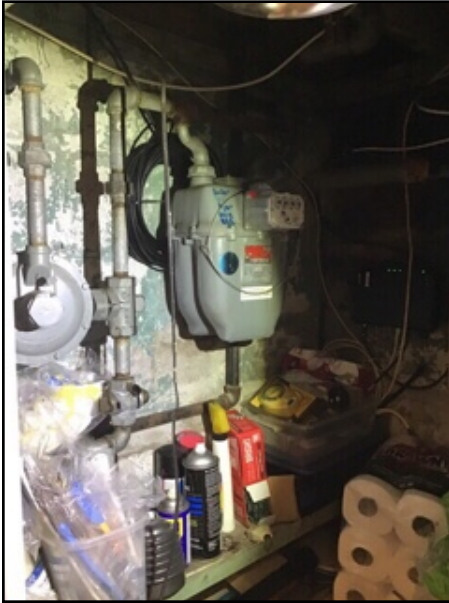
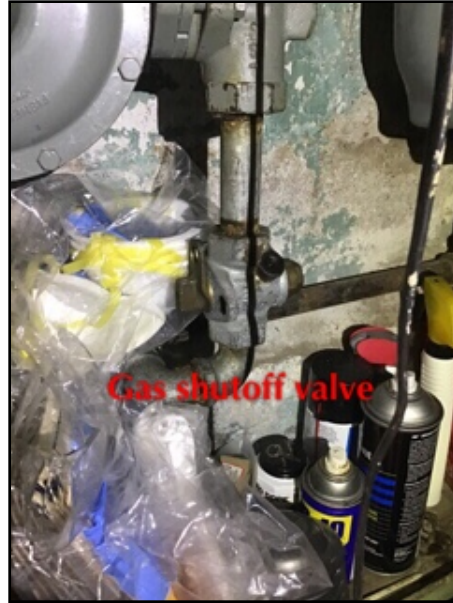
Comment 34:  
Gas meter was located in the basement.

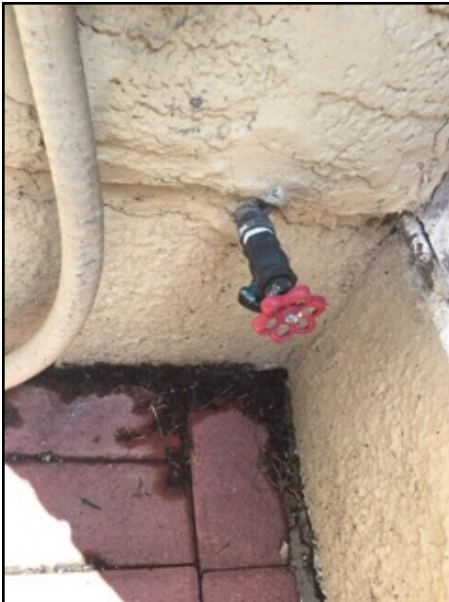
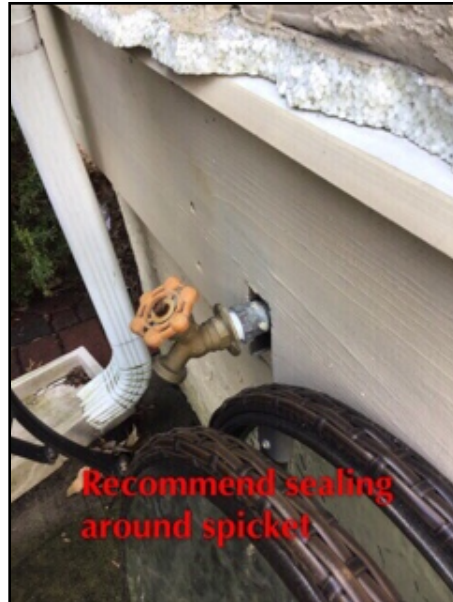
Comment 35:  
Recommend changing outside water spickets to frost free spickets. This is to prevent them from freezing up in the winter.

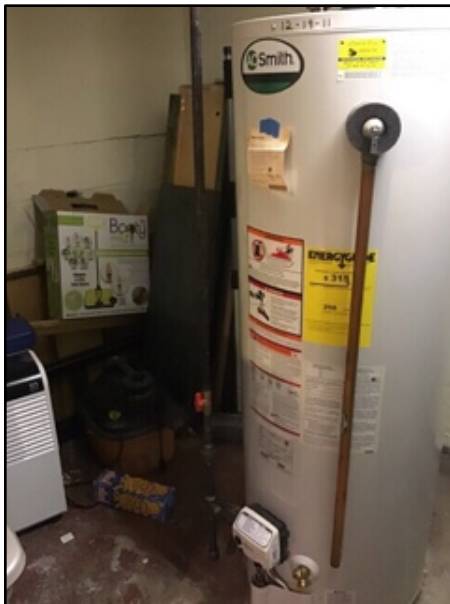
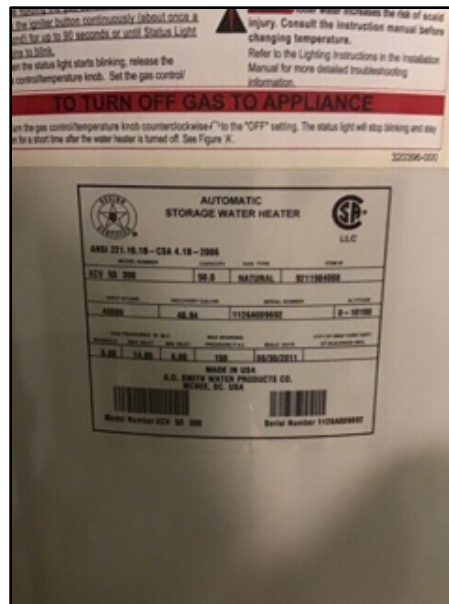
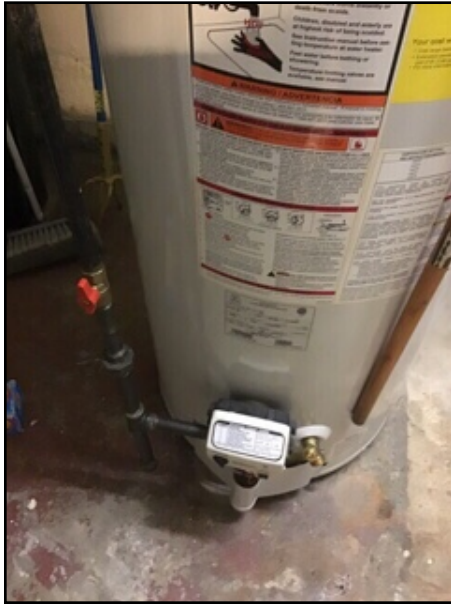
## Comment 36:

The water heater is a 50 gallon gas heated AO Smith tank located in the basement which operated properly on the date of inspection. The tank showed no signs of rust or corrosion and the TPRV valve and extension were noted and proper. Hot water was received at all sinks and tubs in the home.

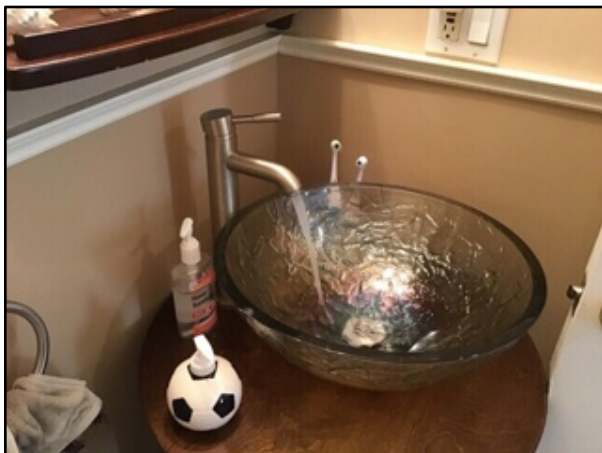
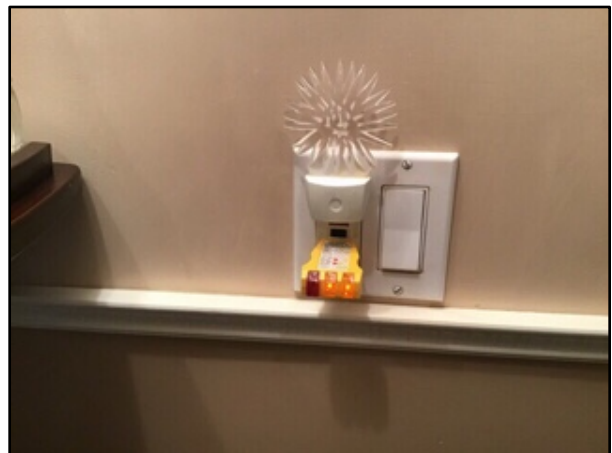
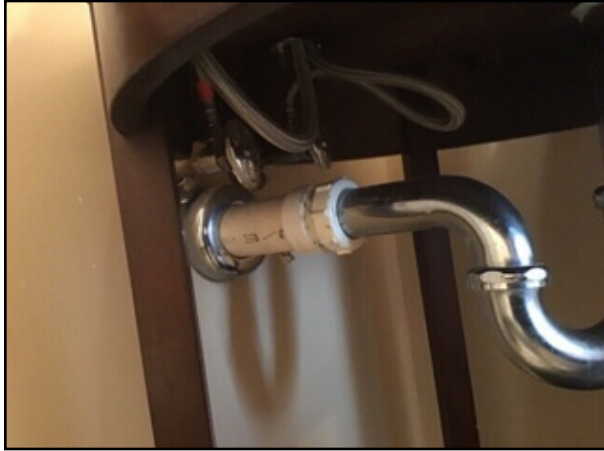
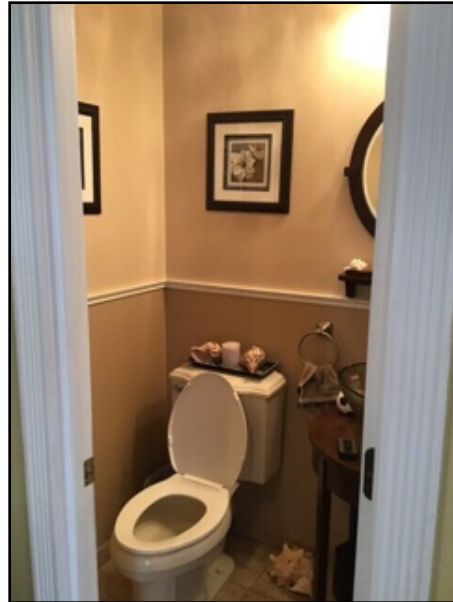
### Comment 38:

The main bath was in working condition with no leaks noted at the sink, toilet . The GFCI outlet was tested and operated properly on the date of inspection. There was an exhaust fan for ventilation and no mold or mildew was noted on the walls or ceiling.

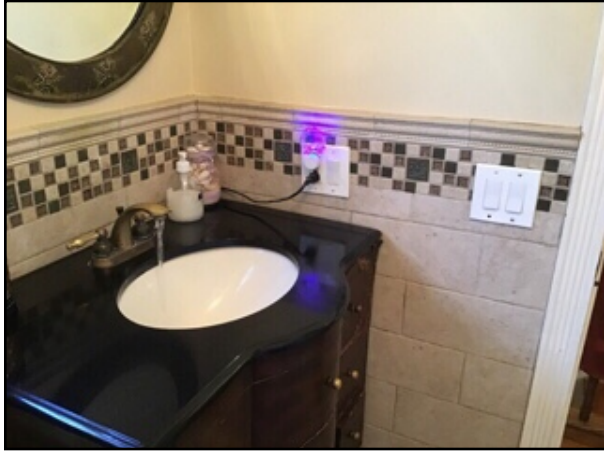
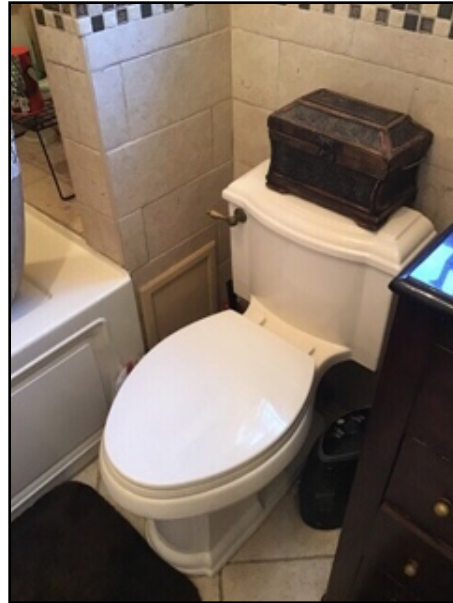
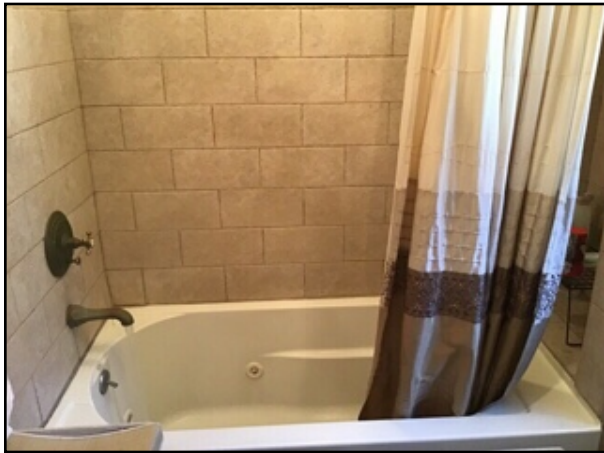
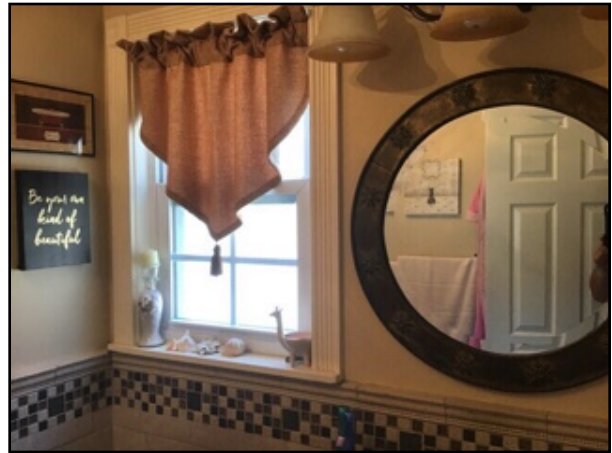
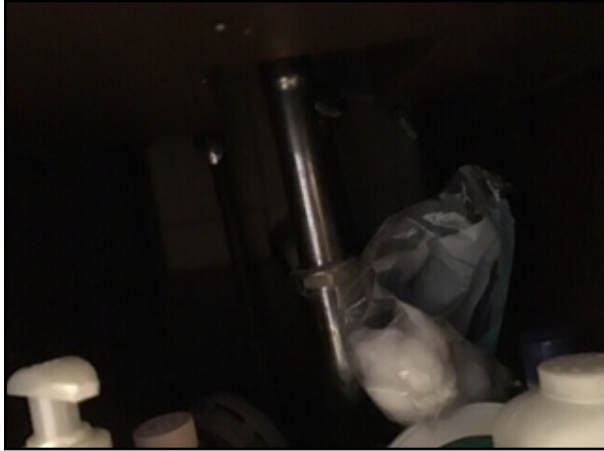
Comment 39:

The main bathroom on the upper floor was in satisfactory condition with no leaks at the sink, tub or toilet. The outlet in the bathroom is a GFCI outlet and work properly on day of inspection .
