# Ground Up Home Inspections

Inspected By: Manny Theocharidis. Lic # 16000098512

## Residential Inspection Report

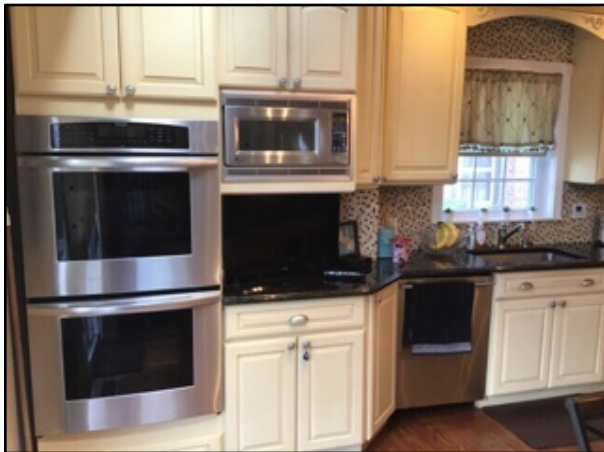
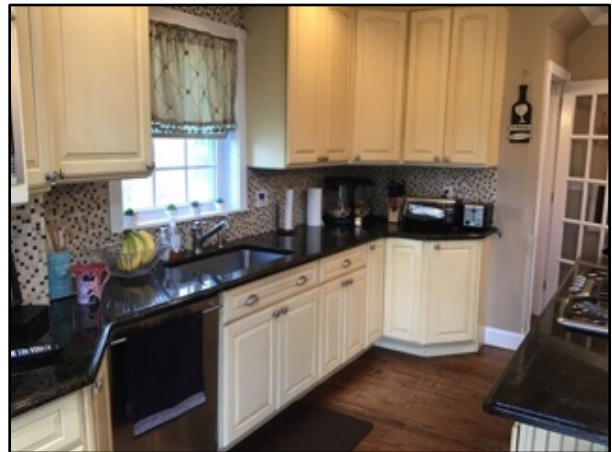
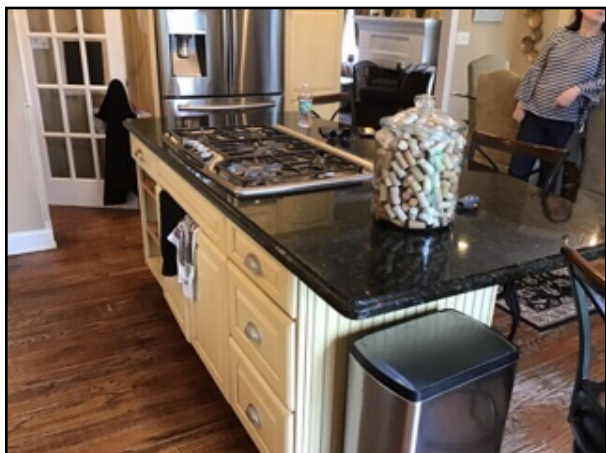
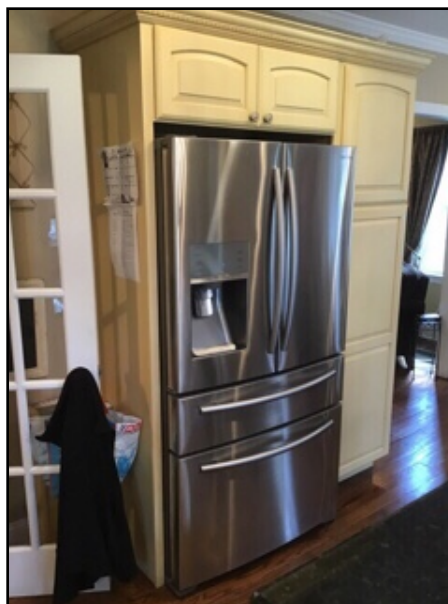
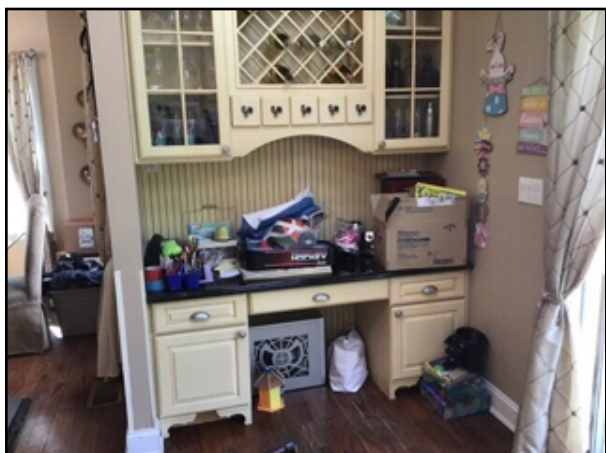
## Comment 42:

The kitchen was in working condition with defects noted. There were no leaks at the dishwasher, and all the appliances were tested and operated properly on the date of inspection. All the cabinets and countertops were operational and secure. The GFCI outlets were tested and operated properly on the date of inspection.

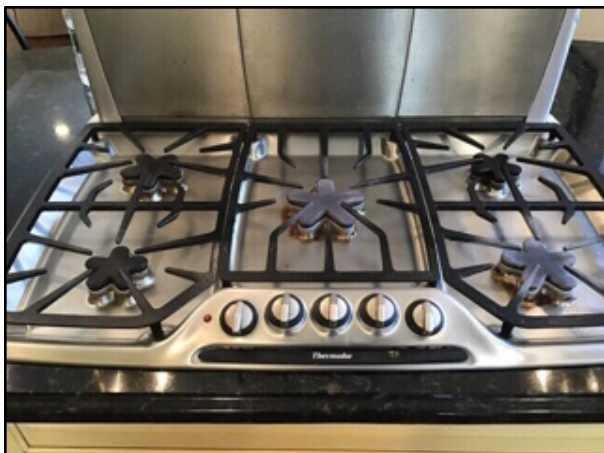
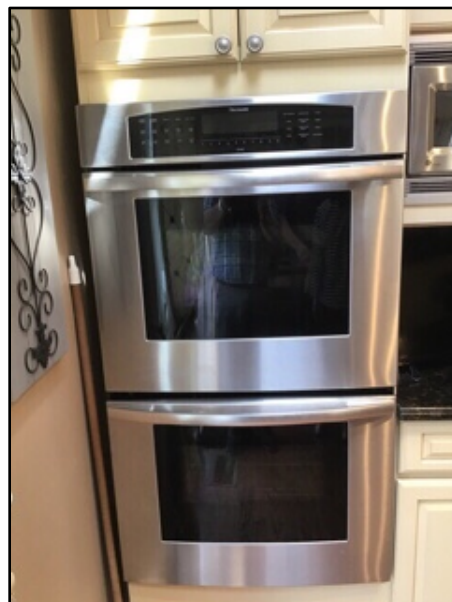
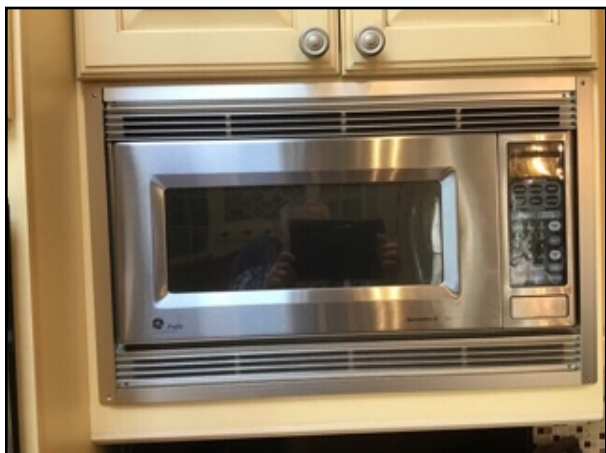
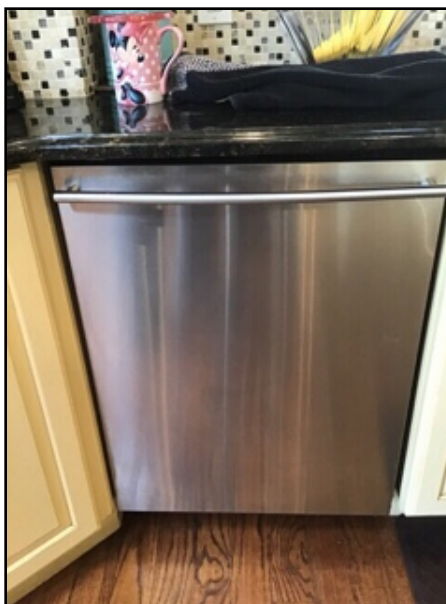
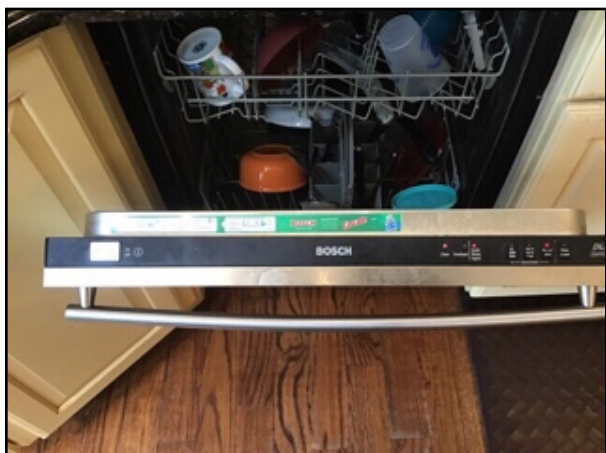
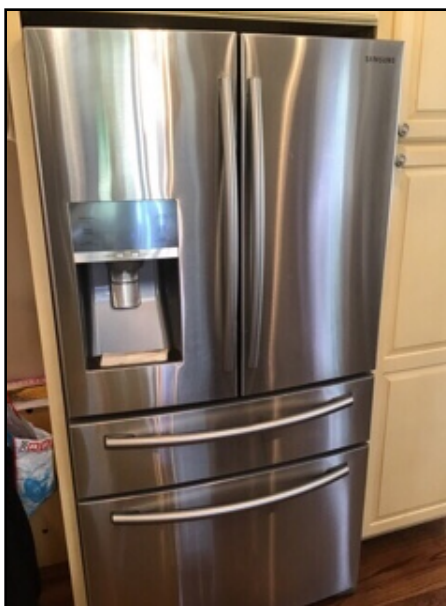
## Comment 45:

All the appliances were tested and were in working condition. The stove was vented by a retractable exhaust fan.

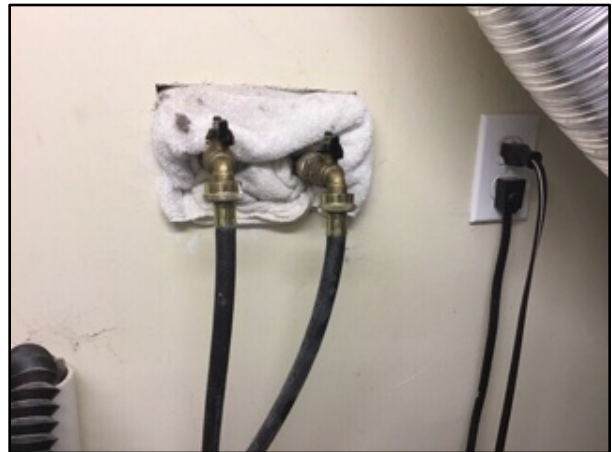
Figure 47-2

The laundry area was in marginal condition with defects noted. There were no leaks at the washing machine connections .

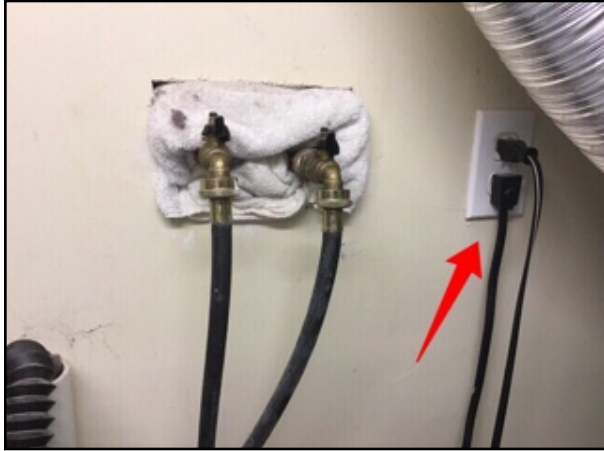
Figure 48-1

The outlet in the laundry area was not a GFCI outlet and is a safety hazard as it is directly below/next to the water supply lines. Recommend hiring a licensed electrician to replace the existing outlet with a GFCI outlet as necessary.

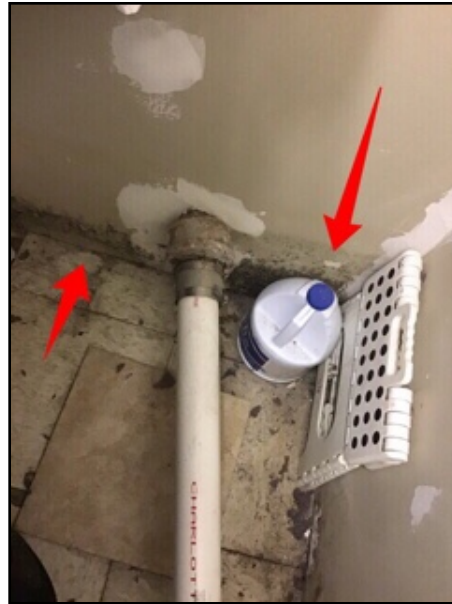
Figure 49-2

**Comment 49:**  
Possible signs of mold in laundry room . Recommend hiring a licensed mold inspector to further evaluate.

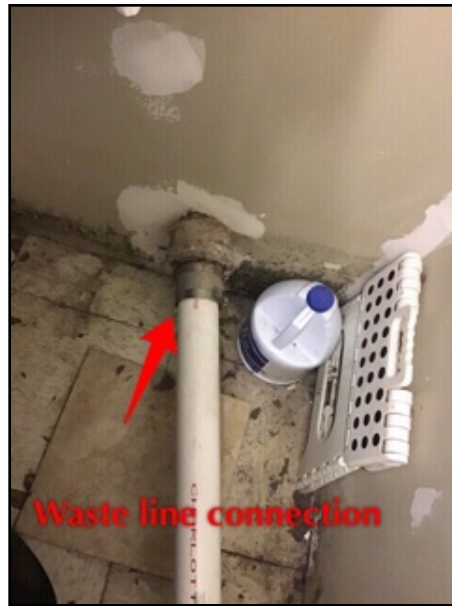
Figure 51-2

The washing machine drain line is not properly secure. Signs of possible leak. Recommend hiring a licensed plumber for further evaluation.

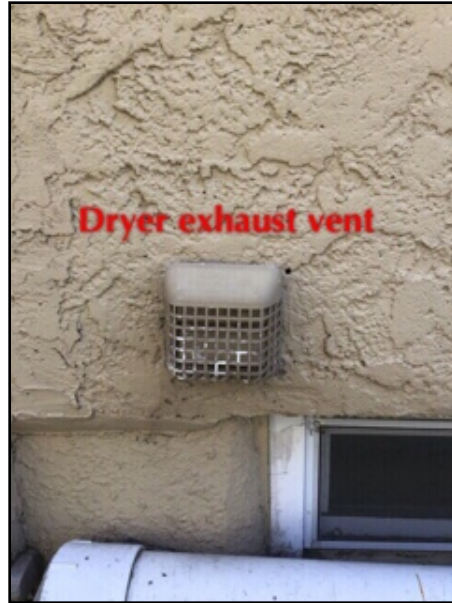
Figure 52-2

The dryer exhaust vent is not installed properly and not properly vented out to the exterior. This needs immediate attention. Do not recommend operating dryer until a licensed contractor further evaluates.

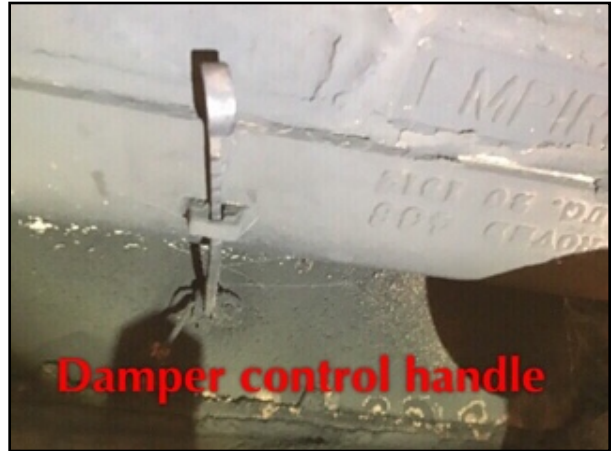
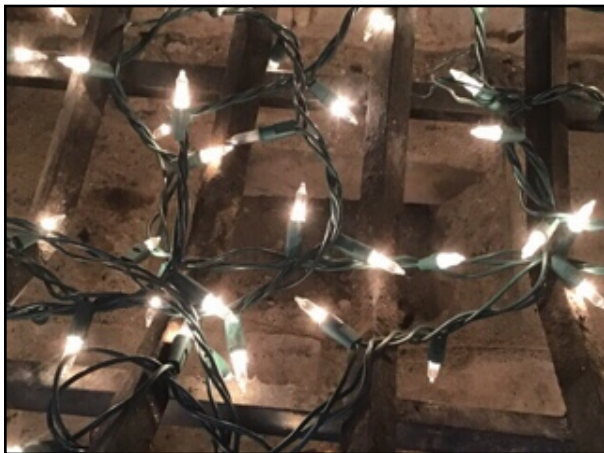
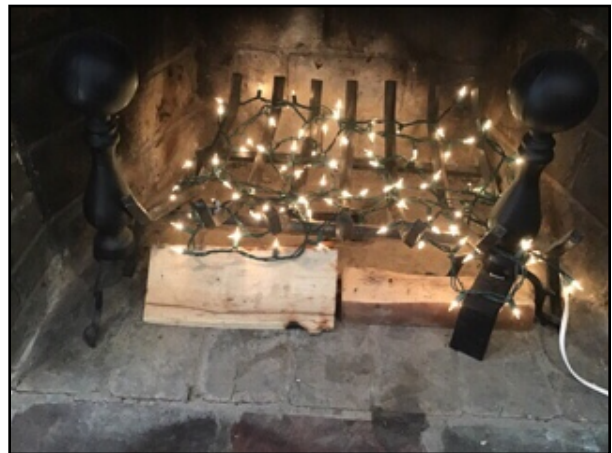
The fireplace is in marginal condition . It is ALWAYS recommended to have the flue inspected and cleaned prior to use. Recommend hiring a qualified chimney company to assess and repair as necessary. Damper was not tested on day of inspection.

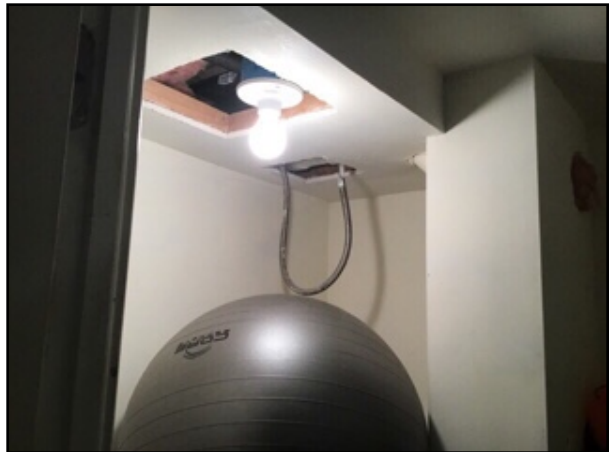
Figure 56-2

The ceiling in the storage closet in the basement needs repair. Recommend hiring a licensed contractor to repair.

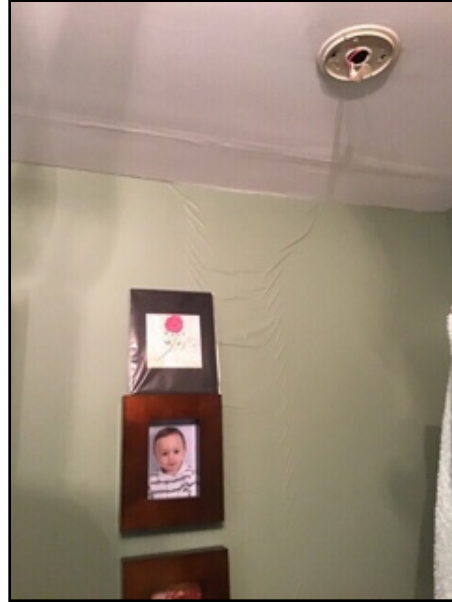
Figure 57-2

The ceiling is peeling as a result from water leak above. Recommend hiring a licensed contractor for further evaluation.

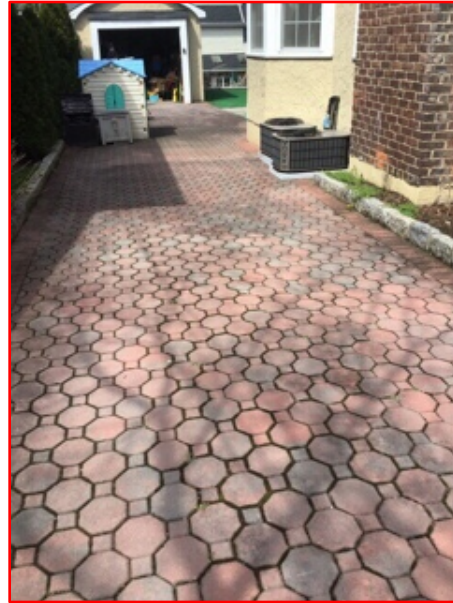
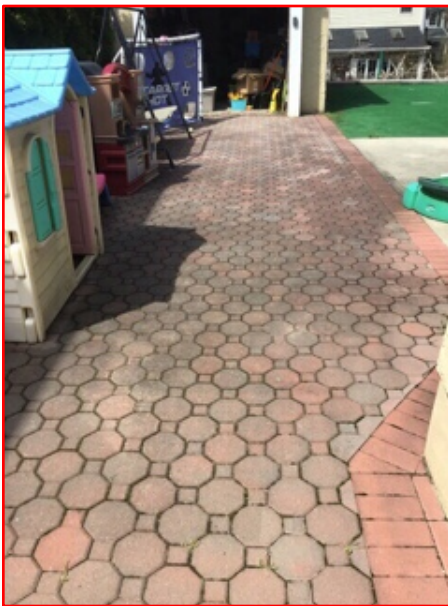
1) The property appears to not be graded properly to allow rain water and melting snow to divert away from the structure when there is a normal amount of precipitation. Recommend monitoring areas around the foundation within 6' for ruts and depressions where areas of water can collect and pool.

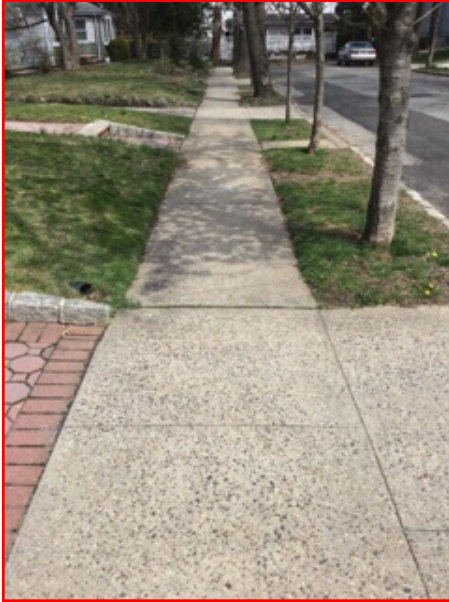
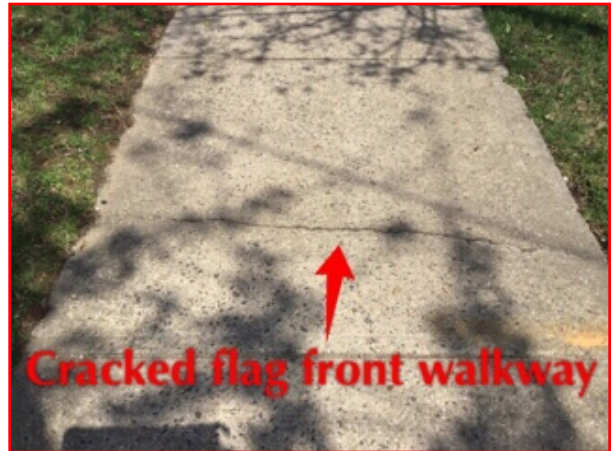
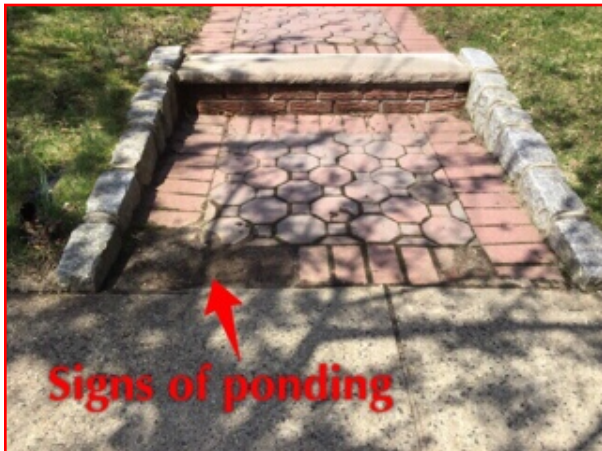
2) The front walkway is in marginal condition with defects noted. Salt and snow melting products are the biggest contributors to surface deterioration. Regular maintenance is required to keep the walkway from deteriorating and cracking.

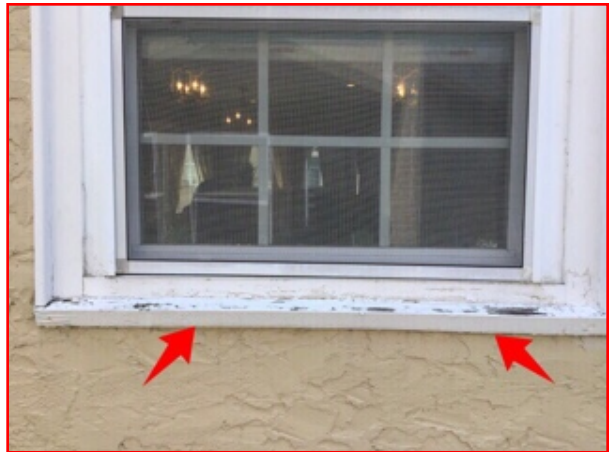
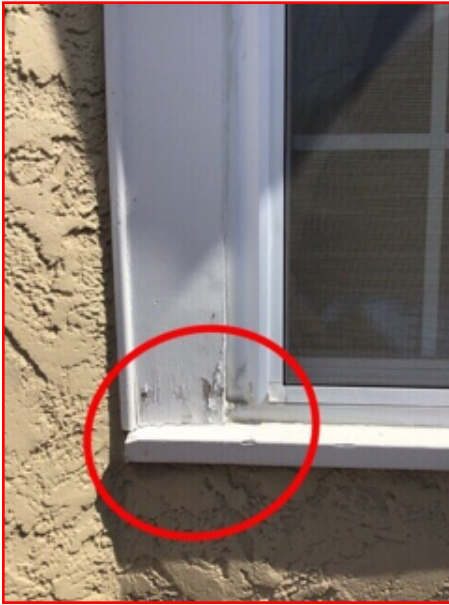
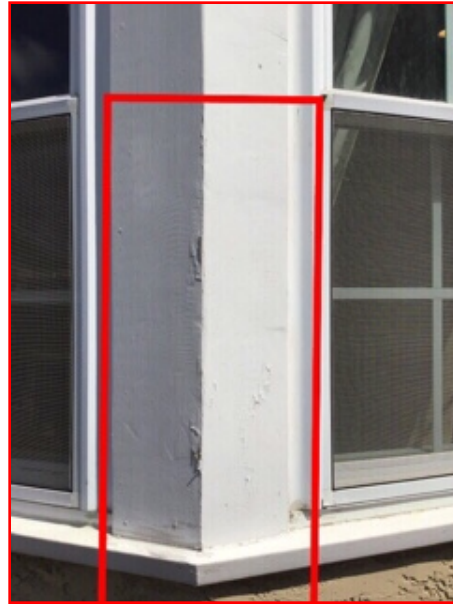
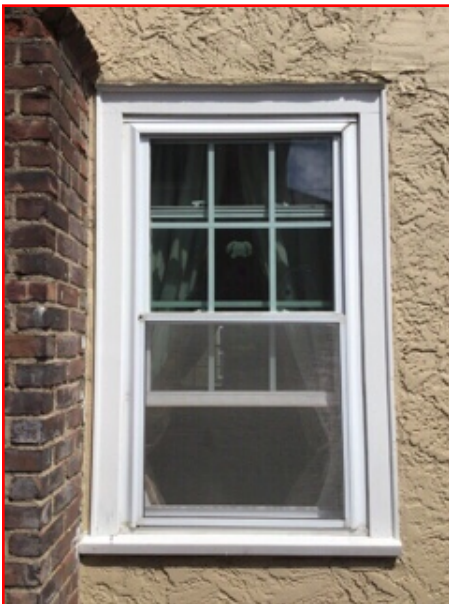
4) The majority of the exterior wood trim of the windows is in poor condition with peeling paint and areas that have started to rot. Recommend hiring a qualified contractor to assess and repair or replace as necessary.

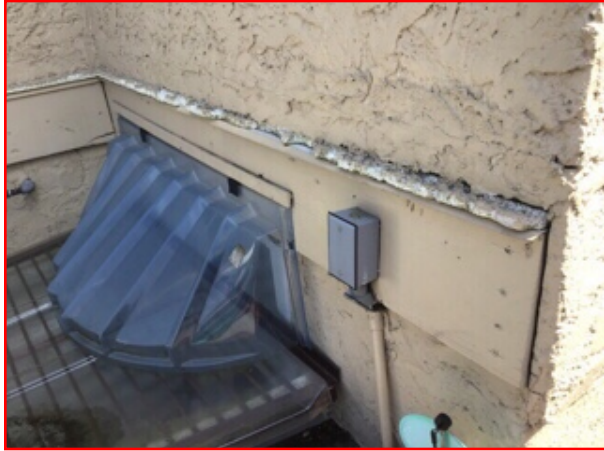
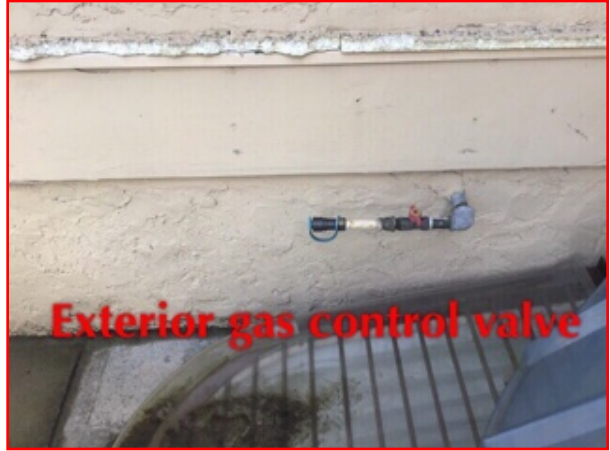
7) The exterior stucco has damage. Unable to inspect behind EIF'S (exterior insulation and finish system) to see if there is any water penetration. Have a licensed EIF'S specialist review for possible repair. If water damage is found have reviewed and repaired by a licensed mold contractor.

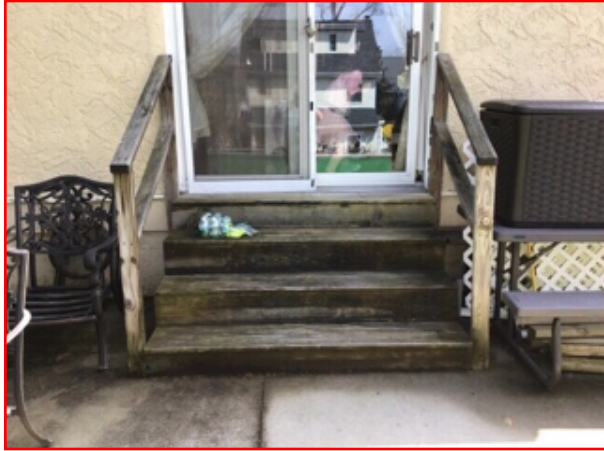
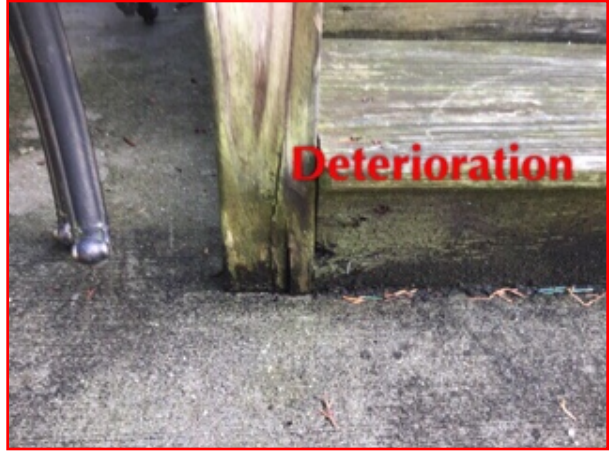
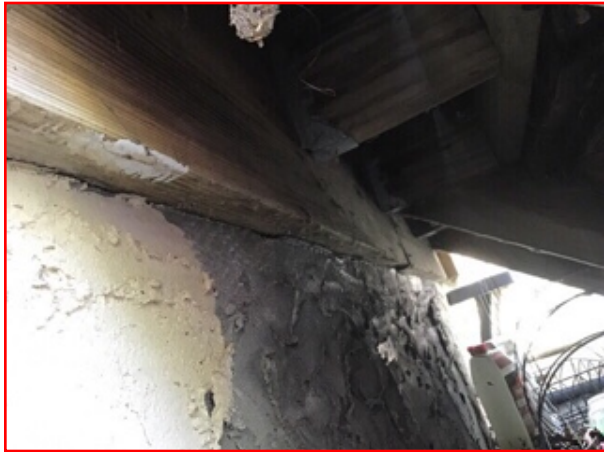
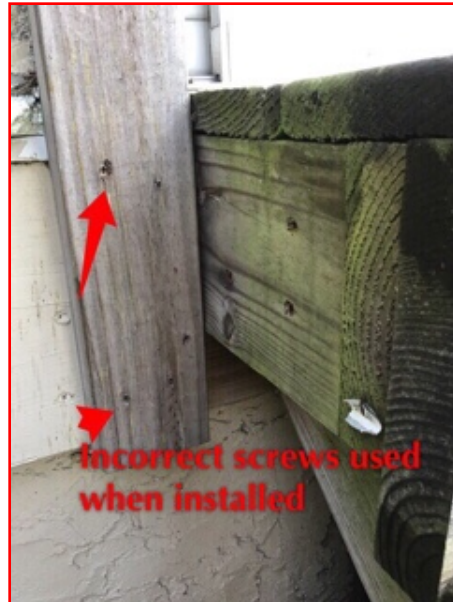
8) The rear steps are in an unsafe condition as they are loose and deteriorating. Recommend hiring a qualified contractor to assess and repair as necessary.

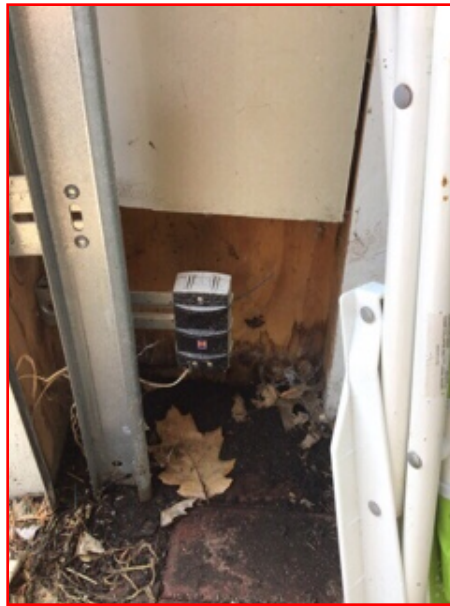
Figure 12-2

9) The garage door shows deterioration on bottom of side jambs.

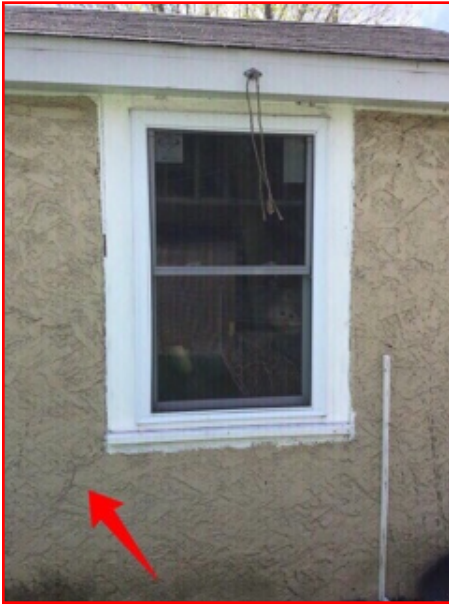
Figure 19-3

13) The side exterior wall was in poor condition with visible crack. Recommend hiring a qualified mason to assess and repair as necessary.

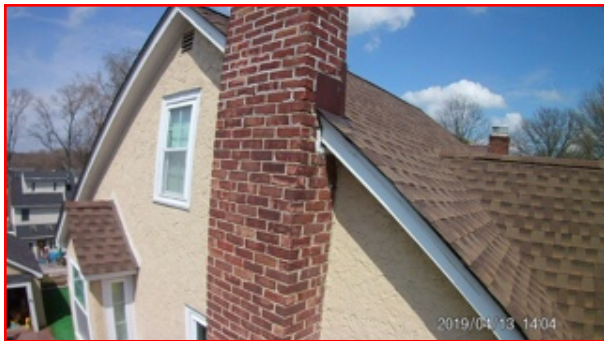
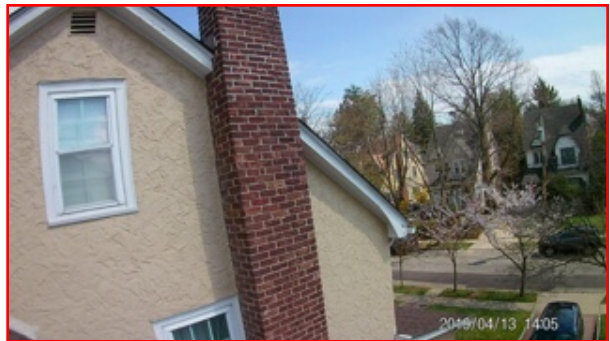
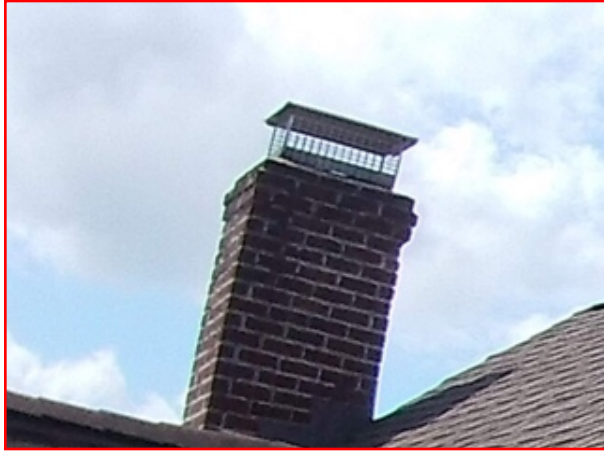
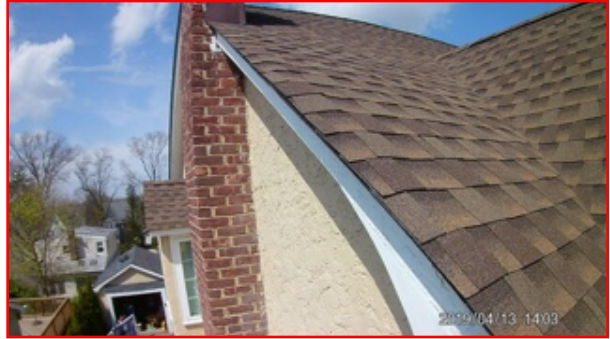
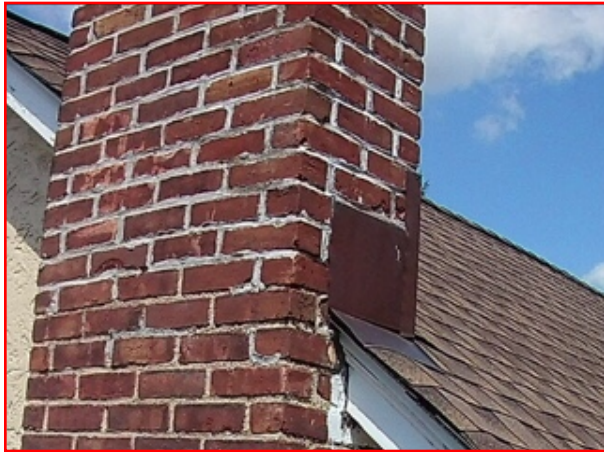
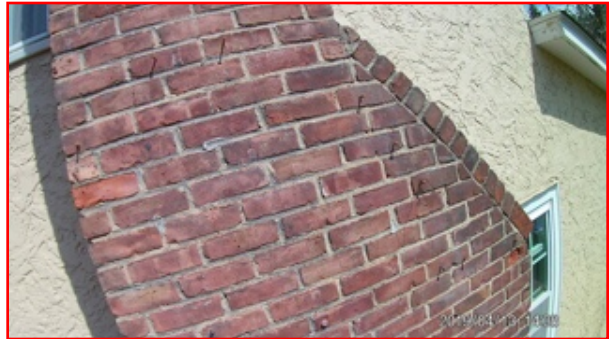
14) The chimney is in need of re-pointing at the top rows as there is signs of deterioration in the mortar joints. Also, there is a proper spark arrestor at the top of the chimney flue which is needed for a fireplace. Recommend hiring a qualified mason to repair as necessary, check the rain cap when he is re-pointing and repairing the chimney.

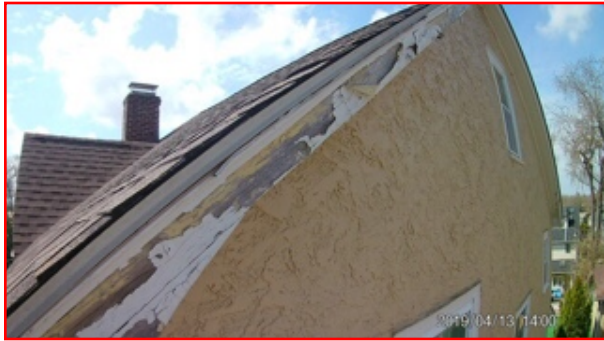
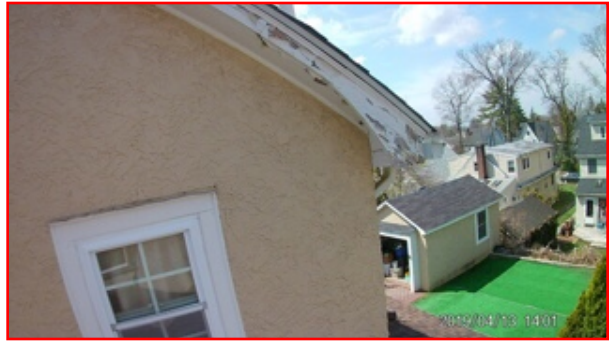
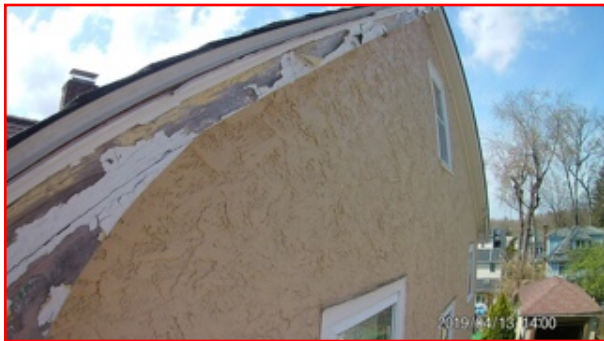
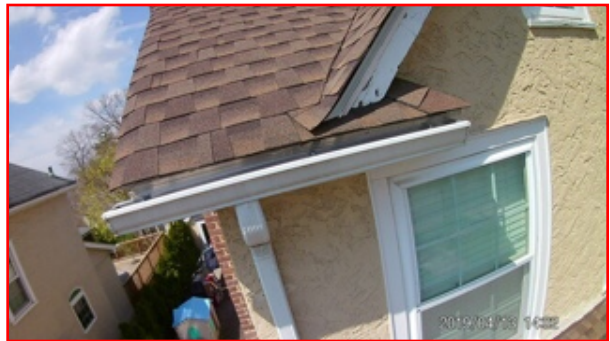
15) The fascias and soffits are wood and are damaged and rotted in numerous places as well as having cracked and peeling paint. Recommend hiring a qualified contractor to assess and repair or replace all defects as necessary.

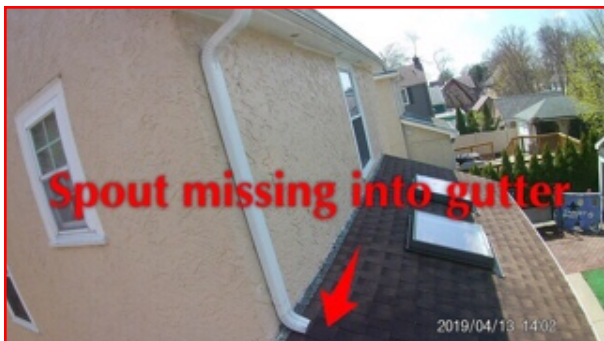
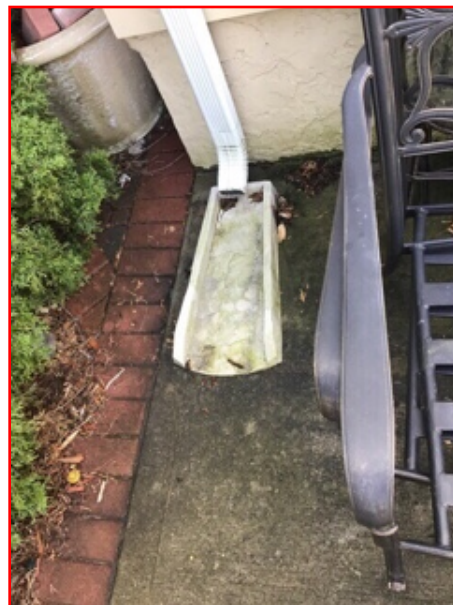
16) The gutters on the house are missing in numerous areas. Recommend hiring a qualified contractor to assess and install proper gutters, leaders and extensions as necessary.

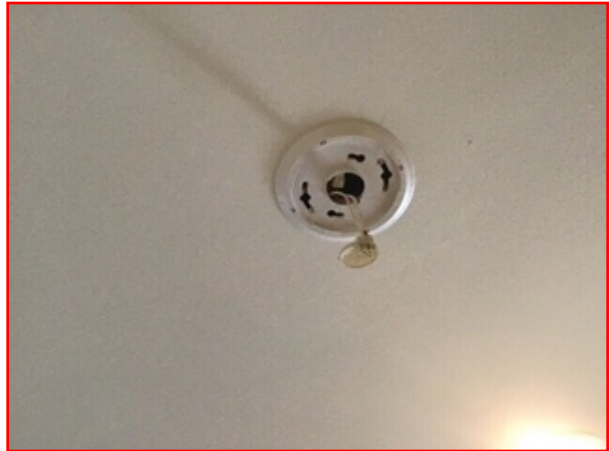
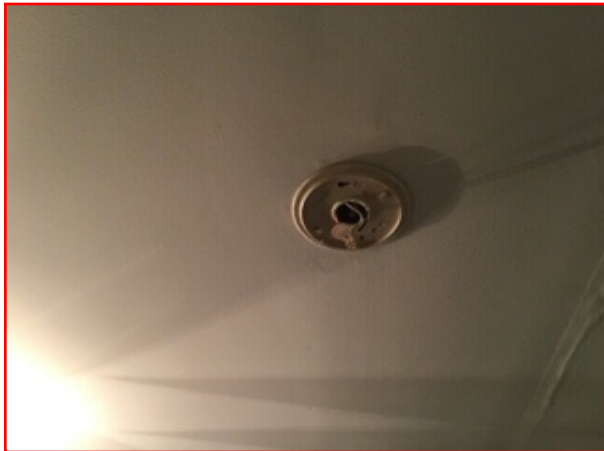
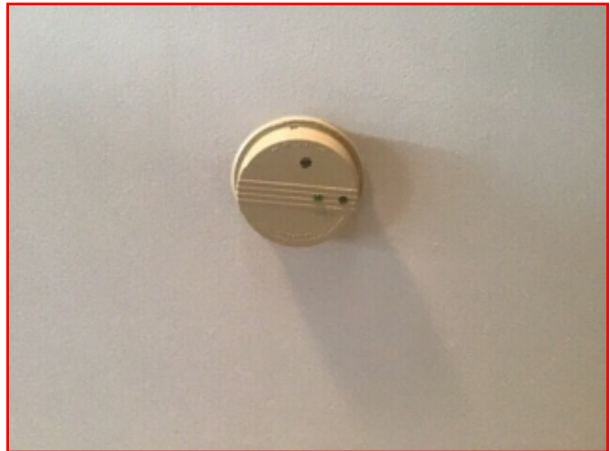
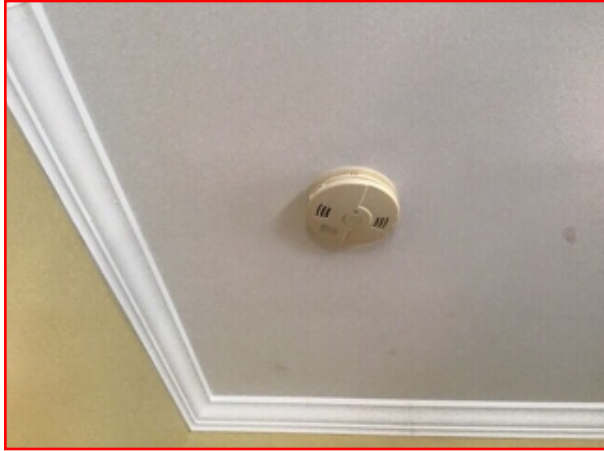
17) Smoke and carbon monoxide detectors are important safety devices designed to save lives. It is always recommended to install new detectors when moving into a home if they are 9 volt battery operated. Noticed on day of inspection some smoke detectors are hard wired and missing. Recommend hiring a licensed electrical contractor to evaluate.

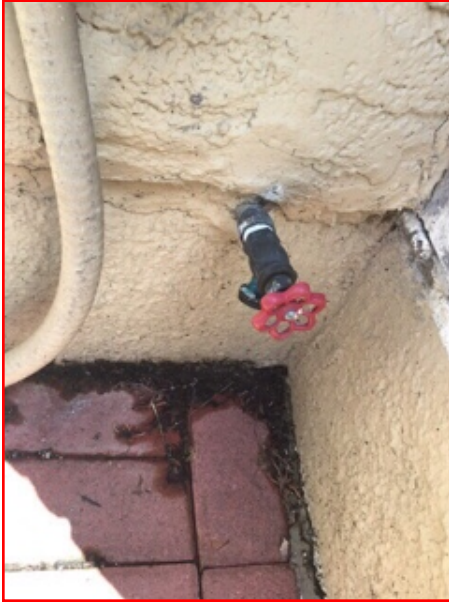
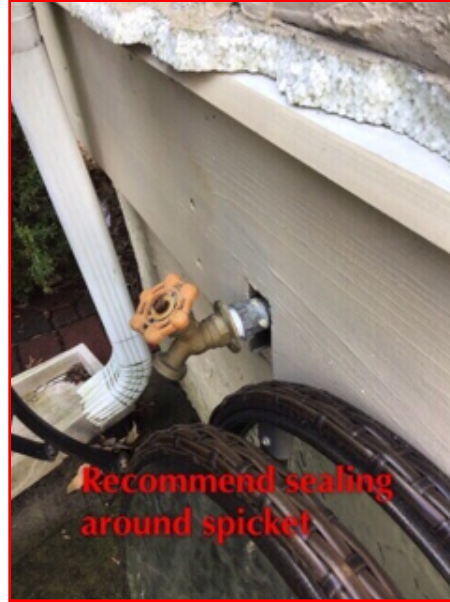
19) Recommend changing outside water spickets to frost free spickets. This is to prevent them from freezing up in the winter.

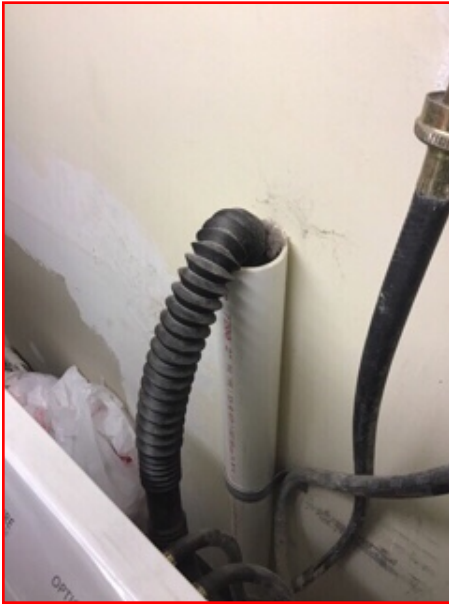
Figure 51-1

27) The washing machine drain line is not properly secure. Signs of possible leak. Recommend hiring a licensed plumber for further evaluation.

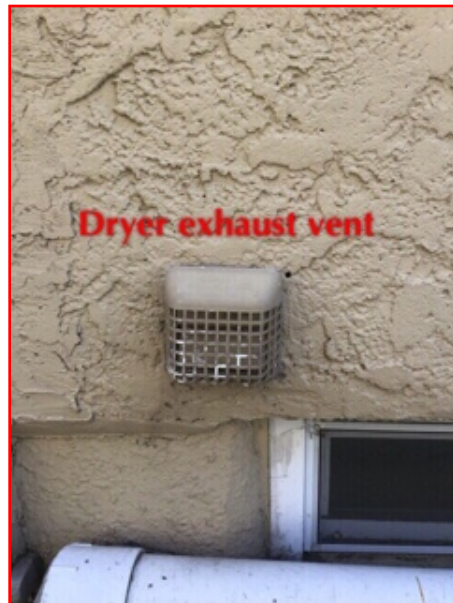
Figure 52-2

28) The dryer exhaust vent is not installed properly and not properly vented out to the exterior. This needs immediate attention. Do not recommend operating dryer until a licensed contractor further evaluates.

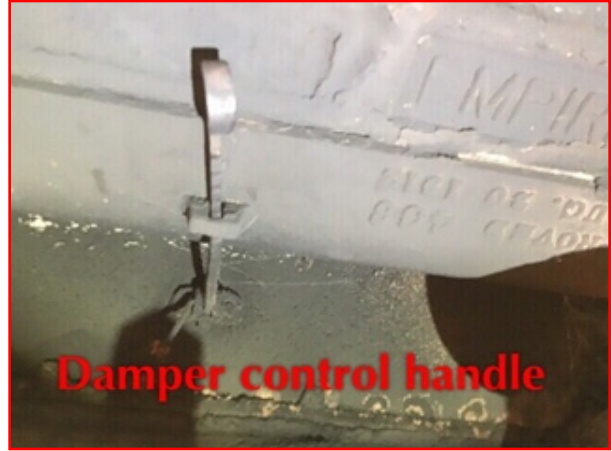
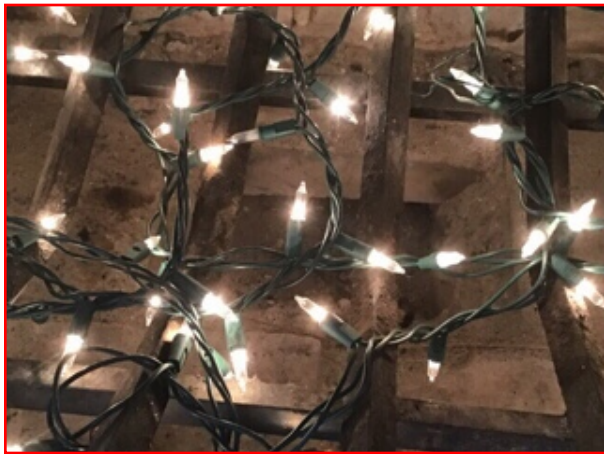
29) The fireplace is in marginal condition . It is ALWAYS recommended to have the flue inspected and cleaned prior to use. Recommend hiring a qualified chimney company to assess and repair as necessary. Damper was not tested on day of inspection.

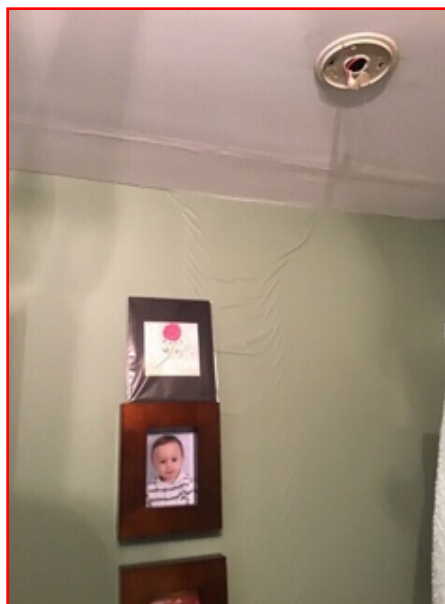
Figure 57-2

32) The ceiling is peeling as a result from water leak above. Recommend hiring a licensed contractor for further evaluation.
